# CEMETERY SURVEY FORM

SITE NAME: Satala Naval Cemetery

LOCATION: Maoputasi County, Tutuila Island, American Samoa

PLOT IDENTIFICATION: 157

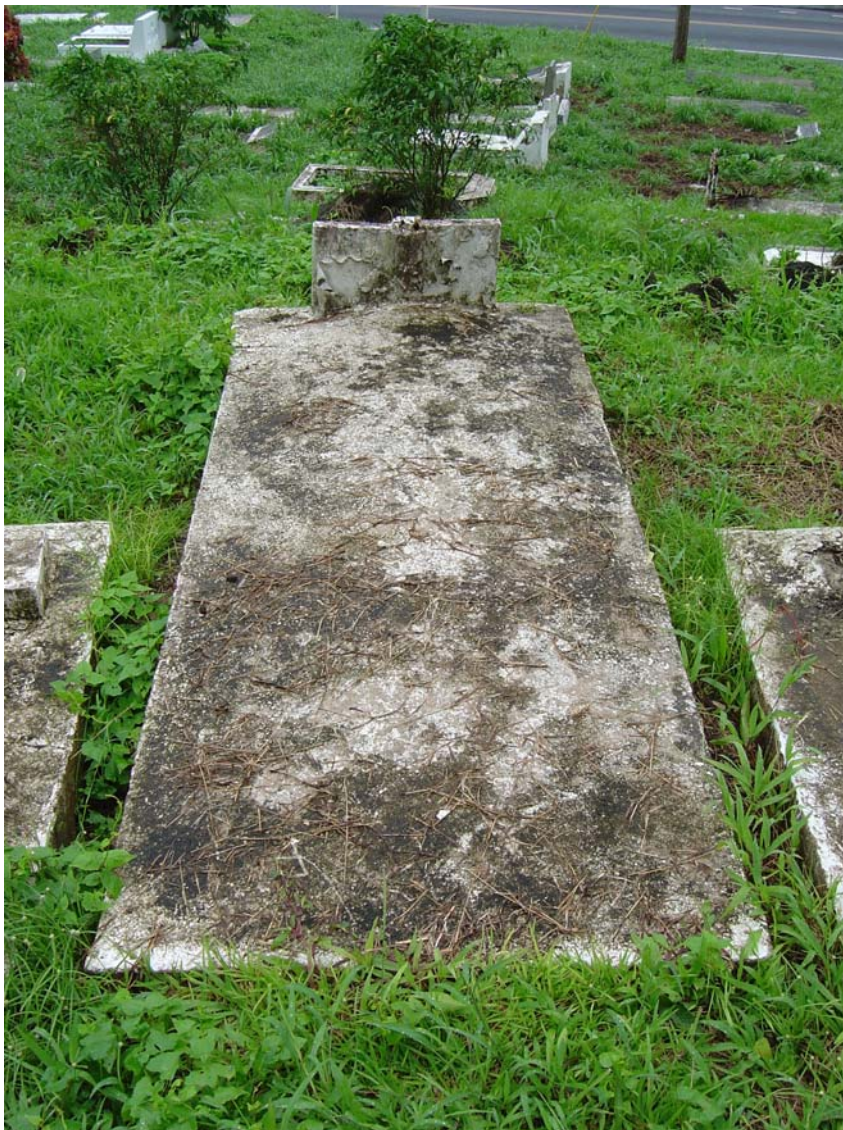
PHOTO:

SUMMARY: Primary structure has some crack and losses. Footstone is broken in half with top half missing. Paint and mildew needs to be removed.
