CEMETERY SURVEY FORM

SITE NAME: Satala Naval Cemetery

PLOT IDENTIFICATION: 158

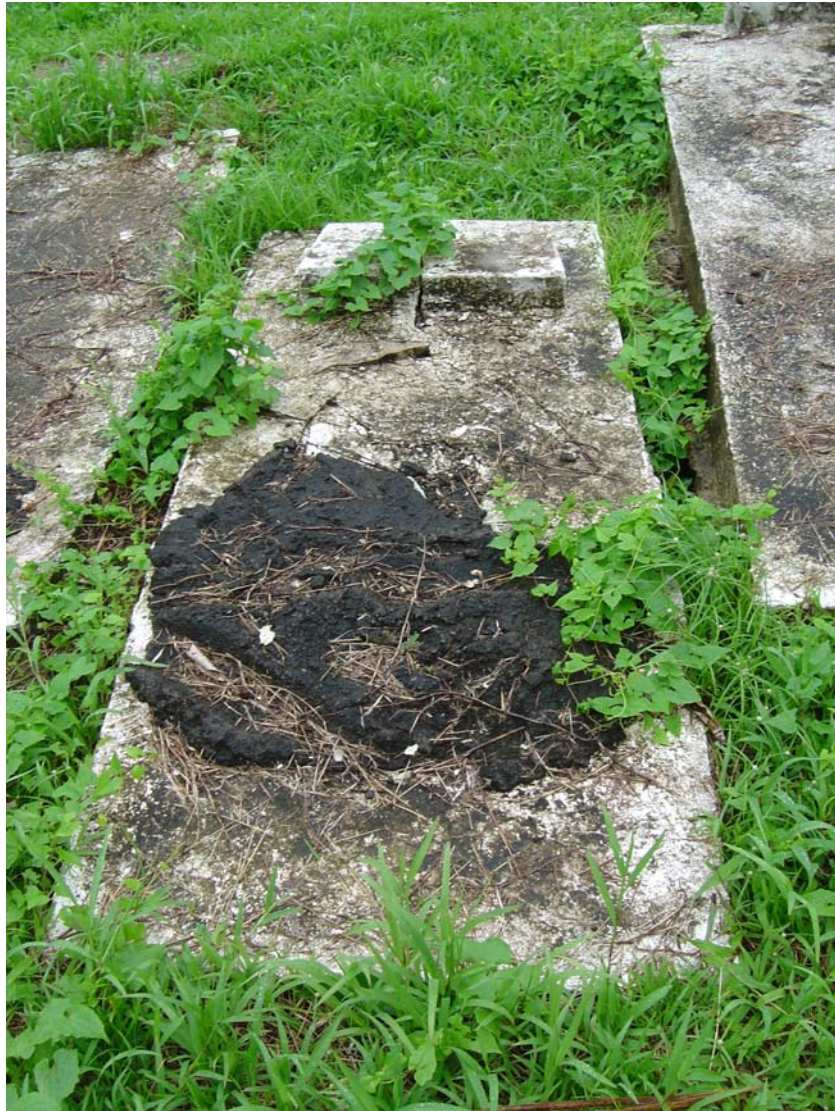
PHOTO:

SUMMARY: Primary structure is broken and fragmented in southeast corner with cracks throughout the rest. Vegetation is growing out of the cracks. There is a clump of tar in the middle of the primary structure. The plaque grave marker is broken in half but still attached to the primary structure. Paint and mildew need to be removed.
