CEMETERY SURVEY FORM

SITE NAME: Satala Naval Cemetery

LOCATION: Maoputasi County, Tutuila Island, American Samoa

PLOT IDENTIFICATION: 159

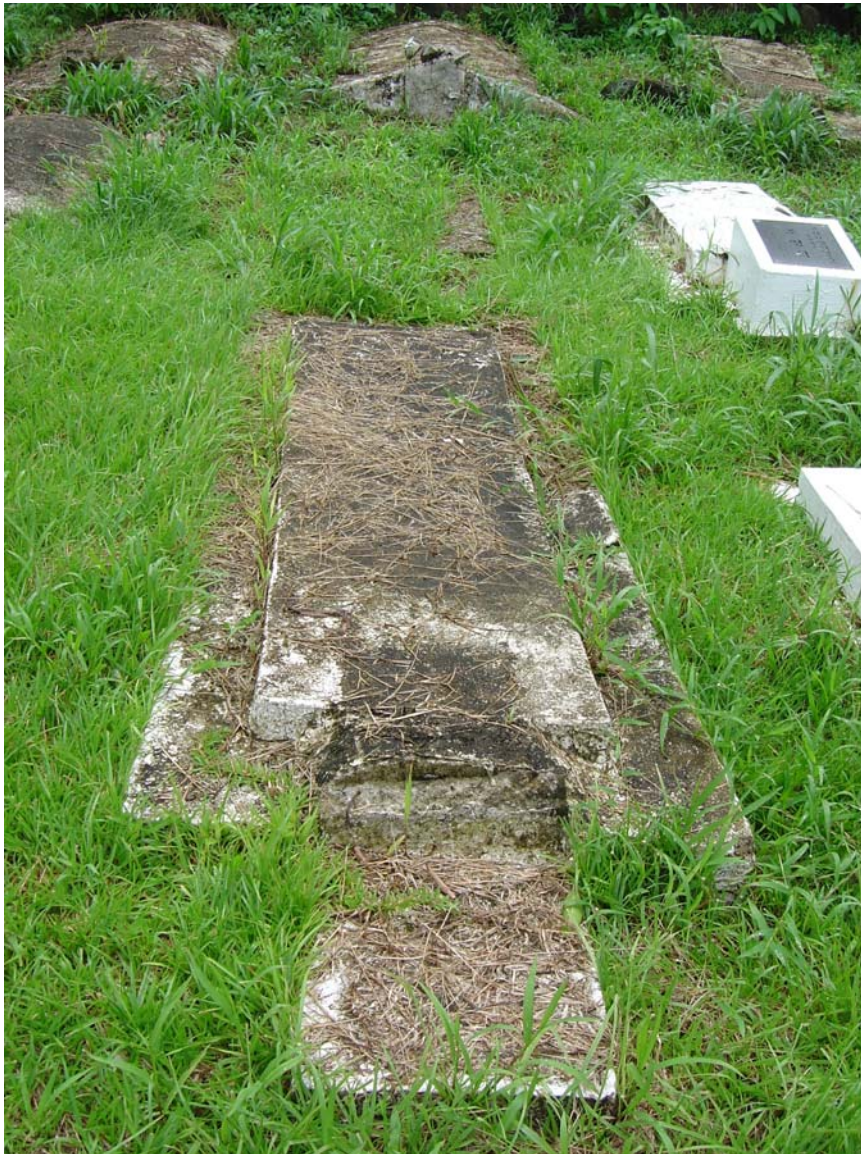
PHOTO:

SUMMARY: Primary structure and base are cracked between joint. Vegetation is growing out of the cracks. The grave marker is broken from primary structure and missing. Paint and mildew need to be removed.
