CEMETERY SURVEY FORM

SITE NAME: Satala Naval Cemetery

PLOT IDENTIFICATION: 16

NAME(S) OF INTERRED: AMANAVE ROSENQUEST

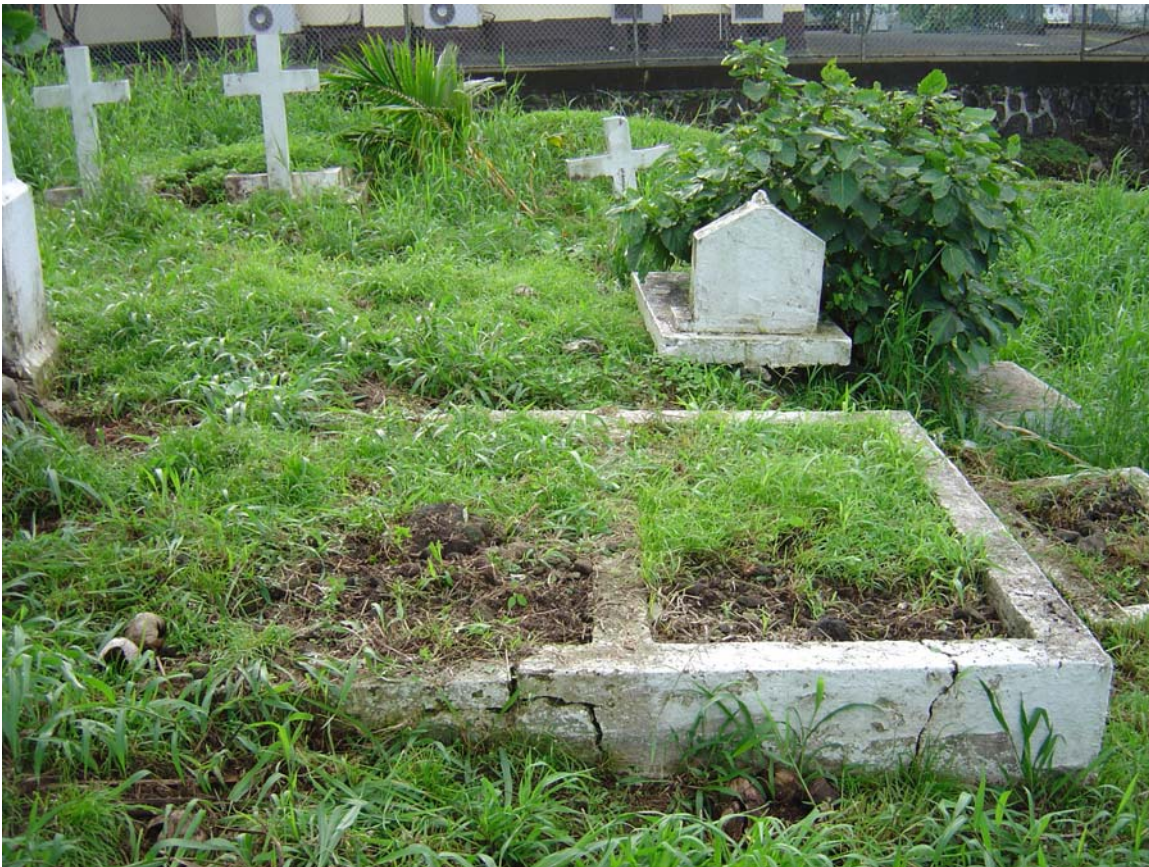
PHOTO: (16 is grave on right side)

SUMMARY: Open concrete frame filled with gravel and coral covered in white paint, mildew and grass. Cracked through frame on west end.
