# CEMETERY SURVEY FORM

SITE NAME: Satala Naval Cemetery

PLOT IDENTIFICATION: 160

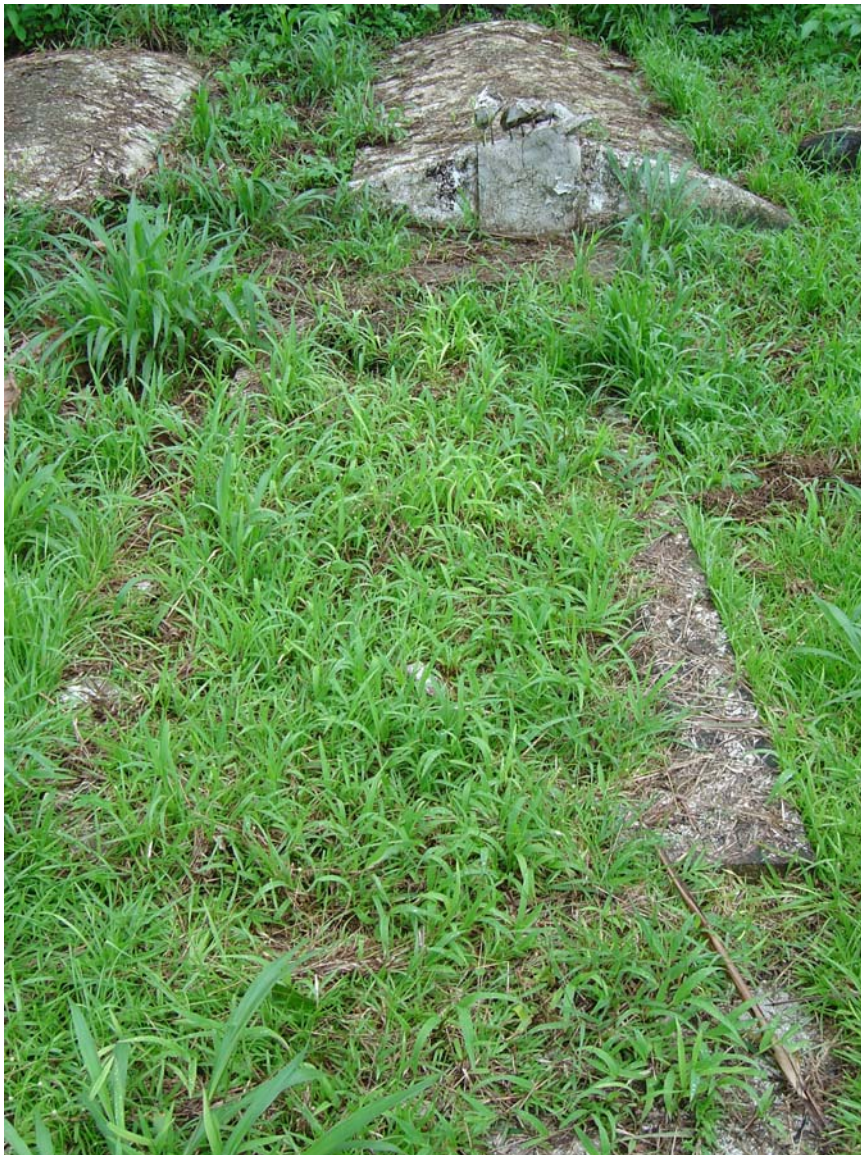
PHOTO:

EXISTING CONDITION	CONSERVATION STRATEGY
<p>POSITION: fallen unstable <b>overgrown</b> tilted marker/ base other _____</p> <p>DETERIORATION: <b>broken</b>   cracked losses flaking/sugaring delaminations/detachment other _____</p> <p>SOILING: <b>biological</b>   general graffiti efflorescence <b>painting</b>   other</p> <p>FAILED TREATMENTS: metal adhesives/coatings mortar other _____</p>	<p>POSITION: reset in ground reset to existing base resquare botom edge remove fragments in setting slot construct new base possible new base required stabilize foundation</p> <p>DETERIORATION: structural adhesion repair mortars crack fillers flowable grouts consolidation</p> <p>SOILING: chemical pressure wash poultice air abrasion</p> <p>FAILED TREATMENTS: drill/grind hand tools solvents air abrasion</p>

SUMMARY: The entire primary structure is broken in half. Paint, vegetation and mildew need to be removed.
