CEMETERY SURVEY FORM

SITE NAME: Satala Naval Cemetery

LOCATION: Maoputasi County, Tutuila Island, American Samoa

PLOT IDENTIFICATION: 161

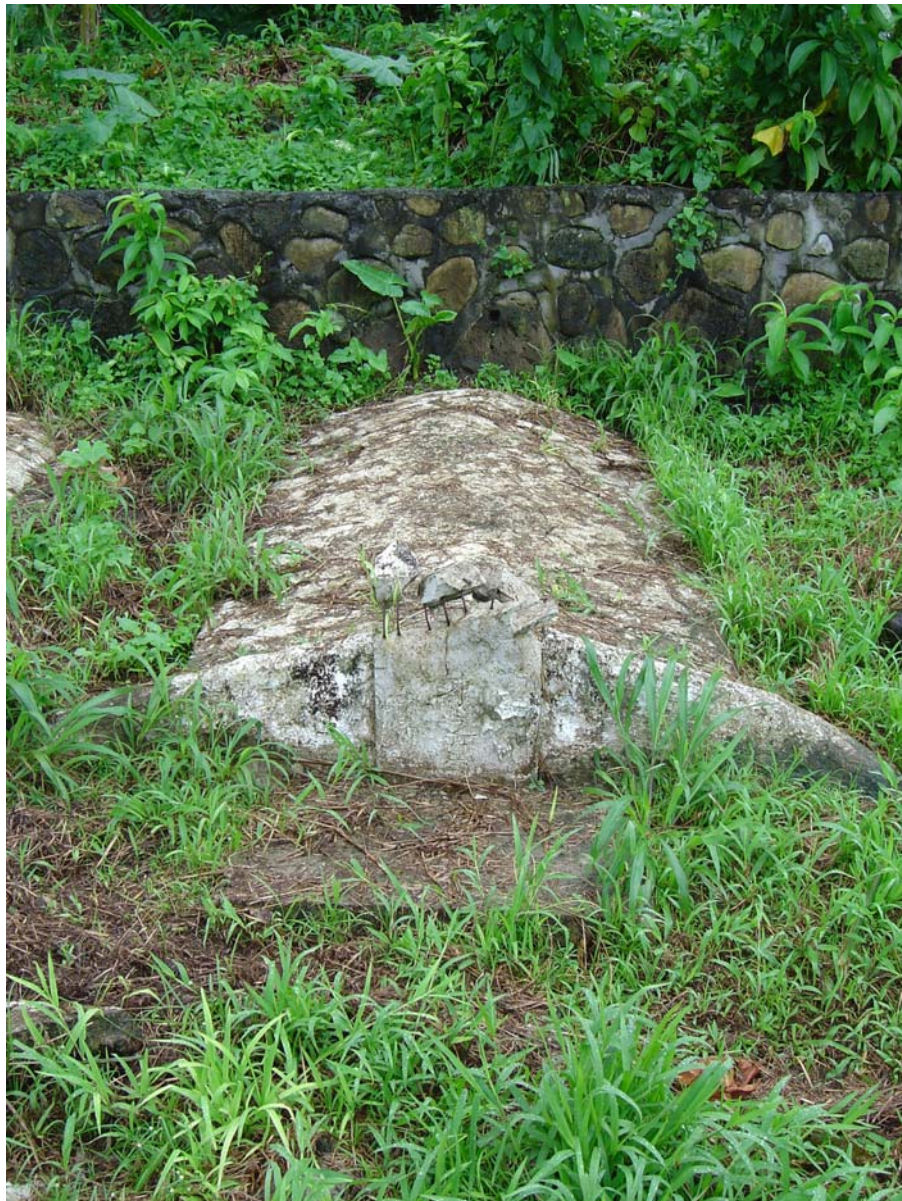
PHOTO:

SUMMARY: The primary structure is cracked with losses. The footstone has been broken in half and top half is fragmented and mostly missing. Paint, vegetation and mildew need to be removed.
