CEMETERY SURVEY FORM

SITE NAME: Satala Naval Cemetery

LOCATION: Maoputasi County, Tutuila Island, American Samoa

PLOT IDENTIFICATION: 162

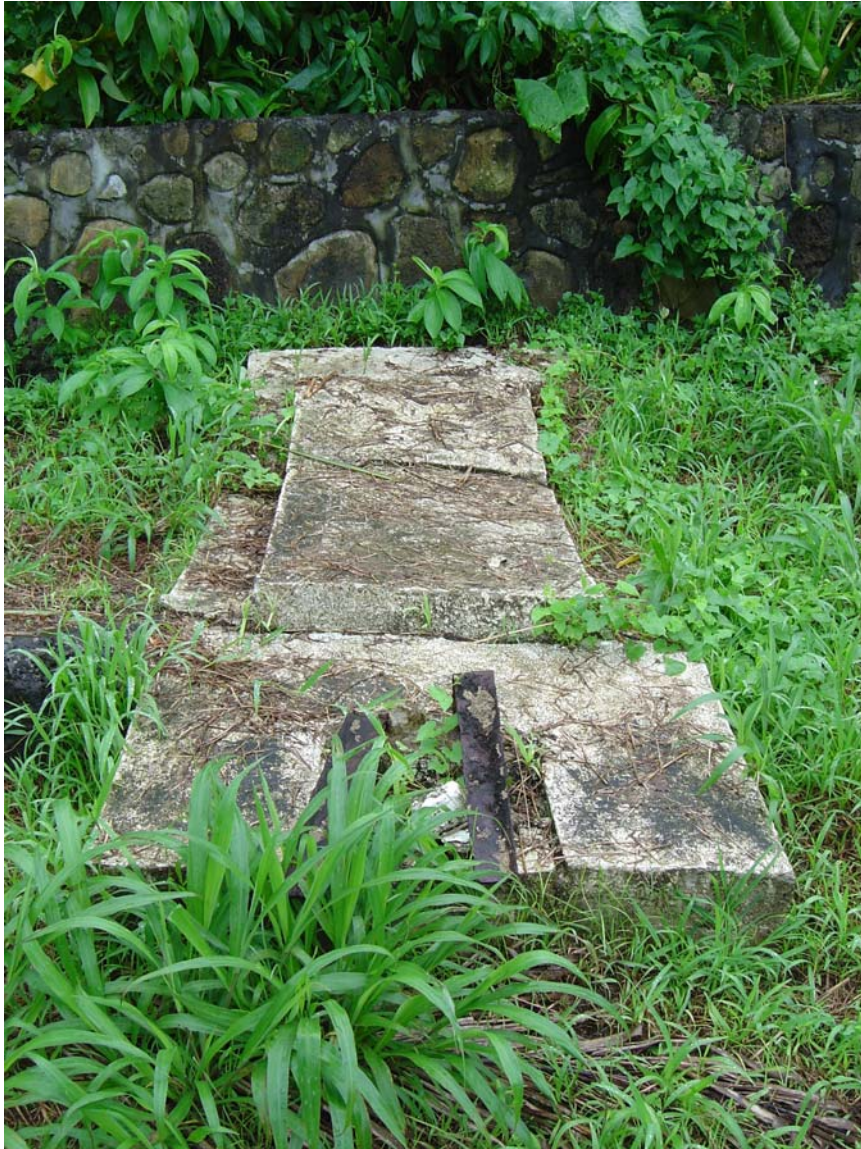
PHOTO:

SUMMARY: The primary structure is broken in half. The base is broken in several places throughout. The grave marker has been broken from its base and is missing. Paint, vegetation and mildew need to be removed.
