# CEMETERY SURVEY FORM

SITE NAME: Satala Naval Cemetery

PLOT IDENTIFICATION: 164

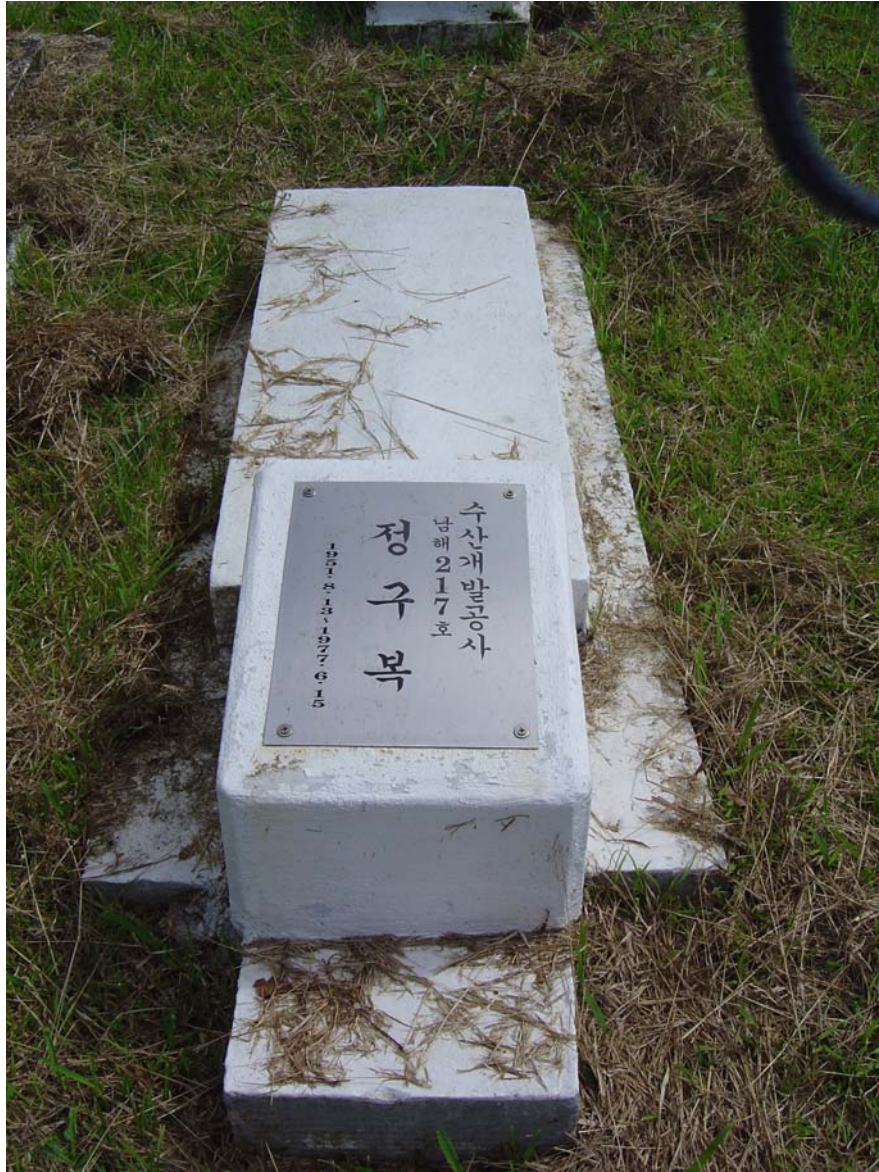
PHOTO:

SUMMARY: Grave is maintained by the American Samoa Korean Association.  
Surrounding vegetation occasionally becomes overgrown. No repairs needed.
