CEMETERY SURVEY FORM

SITE NAME: Satala Naval Cemetery

LOCATION: Maoputasi County, Tutuila Island, American Samoa

PLOT IDENTIFICATION: 165

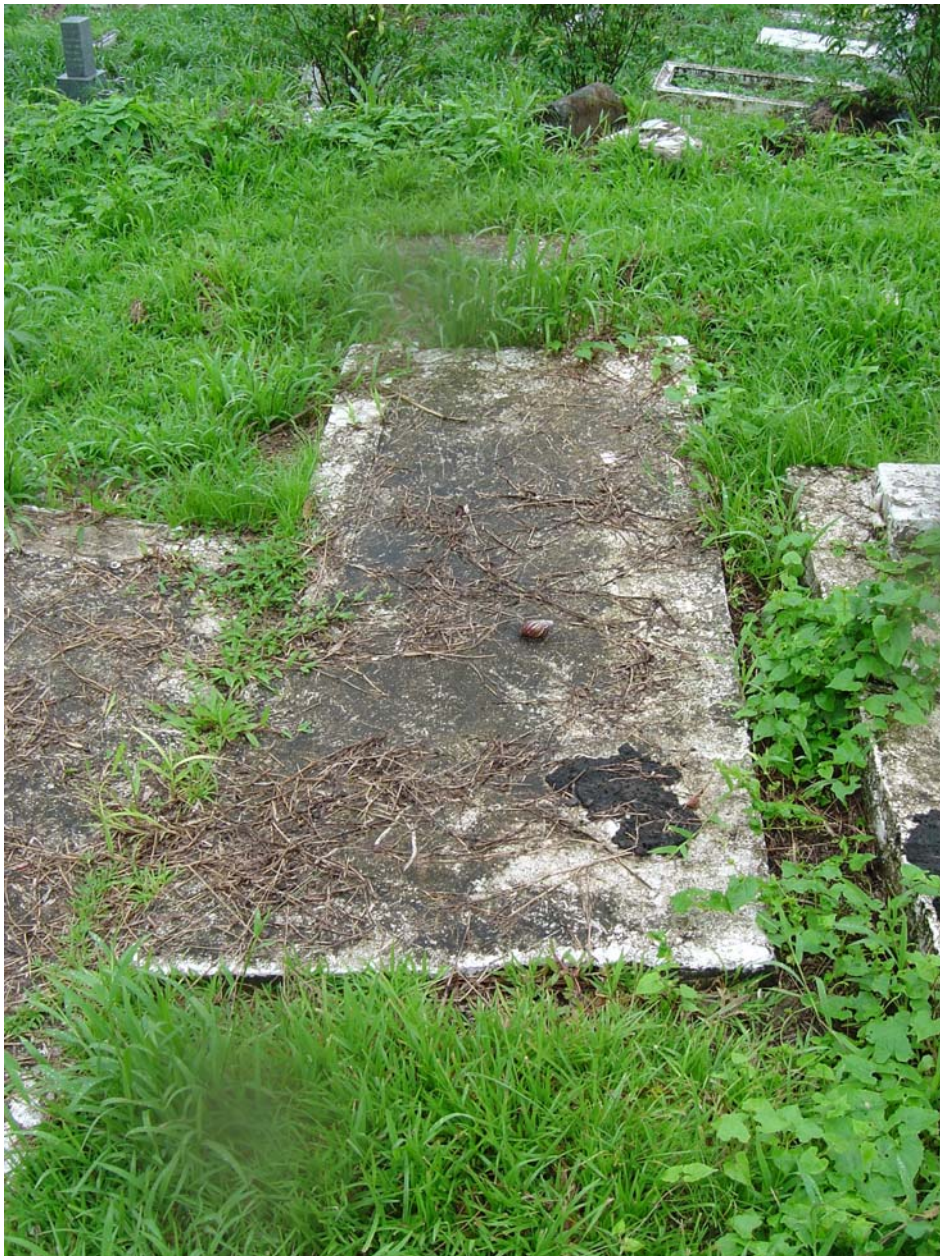
PHOTO:

SUMMARY: The primary structure has some small cracks and losses. There is a small amount of tar on the surface. Paint, vegetation and mildew need to be removed.
