CEMETERY SURVEY FORM

SITE NAME: Satala Naval Cemetery

PLOT IDENTIFICATION: 166

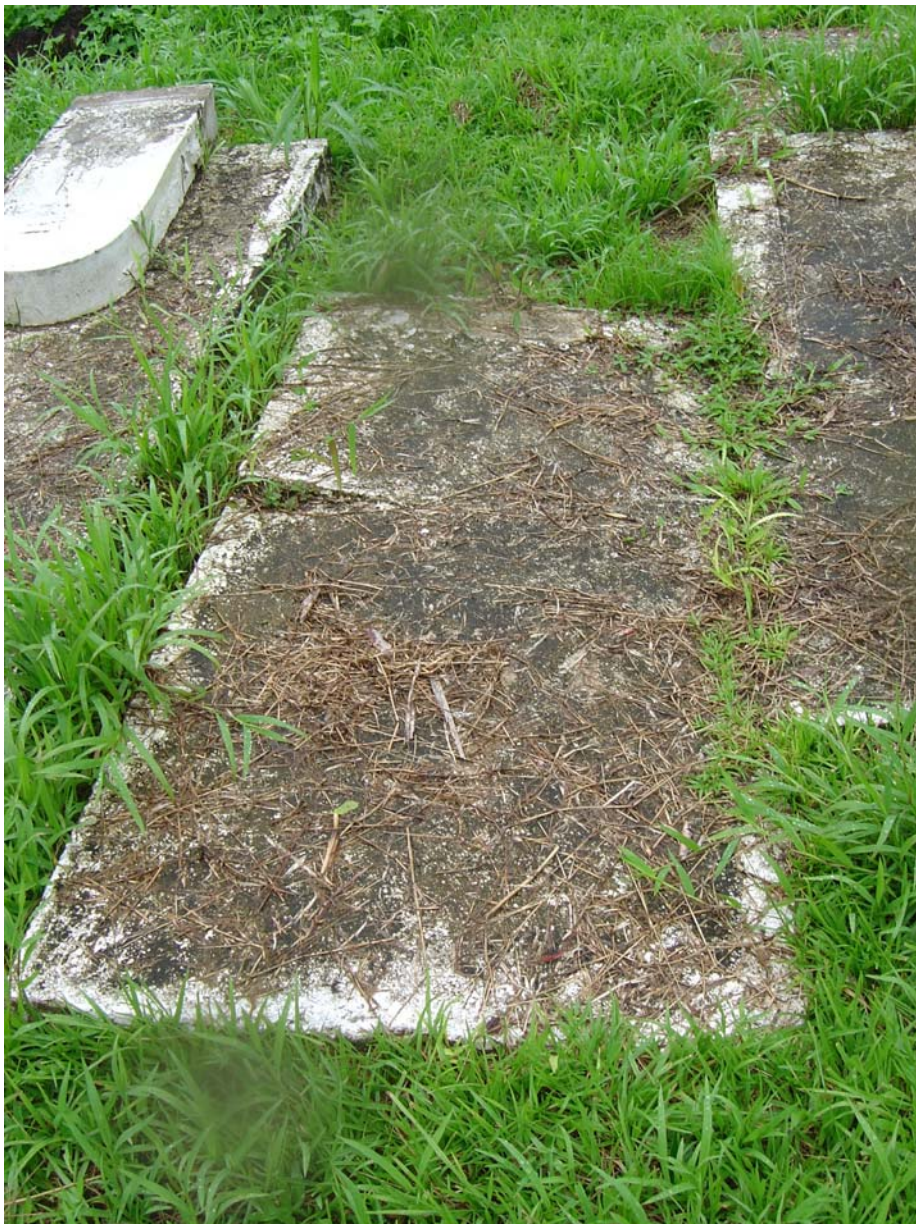
PHOTO:

SUMMARY: The primary structure has some small cracks and losses along the east edge. Paint, vegetation and mildew need to be removed.
