# CEMETERY SURVEY FORM

SITE NAME: Satala Naval Cemetery

PLOT IDENTIFICATION: 169

NAME(S) OF INTERRED: Young Bu Kim

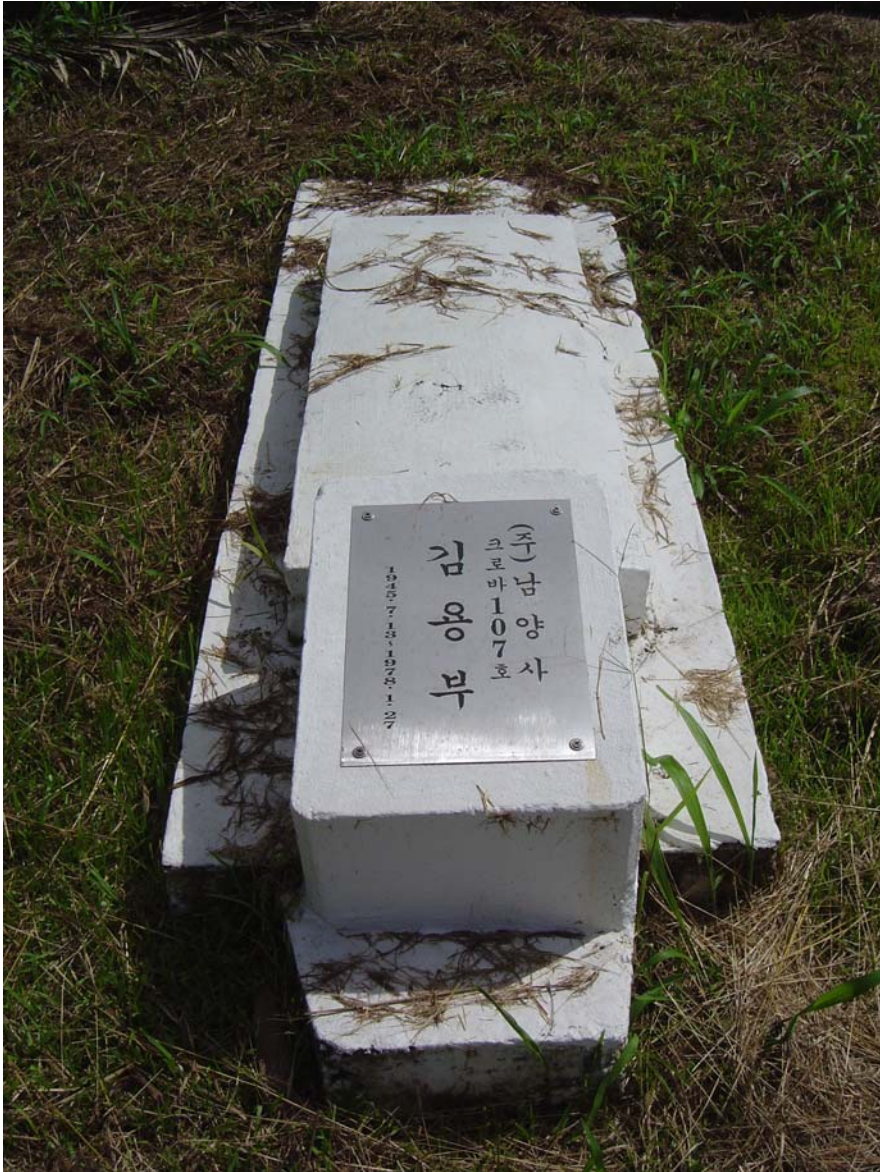
PHOTO:

SUMMARY: Grave is maintained by the American Samoa Korean Association.  
Surrounding vegetation occasionally becomes overgrown. No repairs needed.
