CEMETERY SURVEY FORM

SITE NAME: Satala Naval Cemetery

PLOT IDENTIFICATION: 17

NAME(S) OF INTERRED: MARY KENNISON

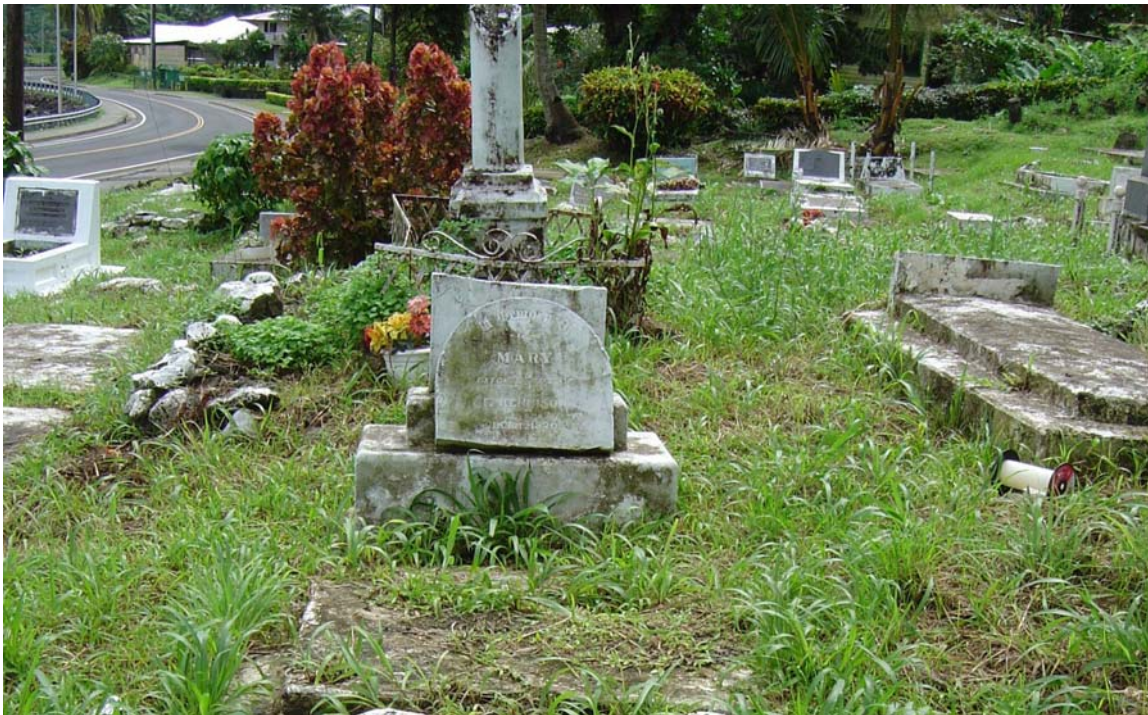
PHOTO:

SUMMARY: The primary structure is cracked and broken with grass growing in cracks. Headstone is broken in half, both pieces available, bottom still standing. Base of grave is fragmented; grave connected to 17A.
