CEMETERY SURVEY FORM

SITE NAME: Satala Naval Cemetery

LOCATION: Maoputasi County, Tutuila Island, American Samoa

PLOT IDENTIFICATION: 170

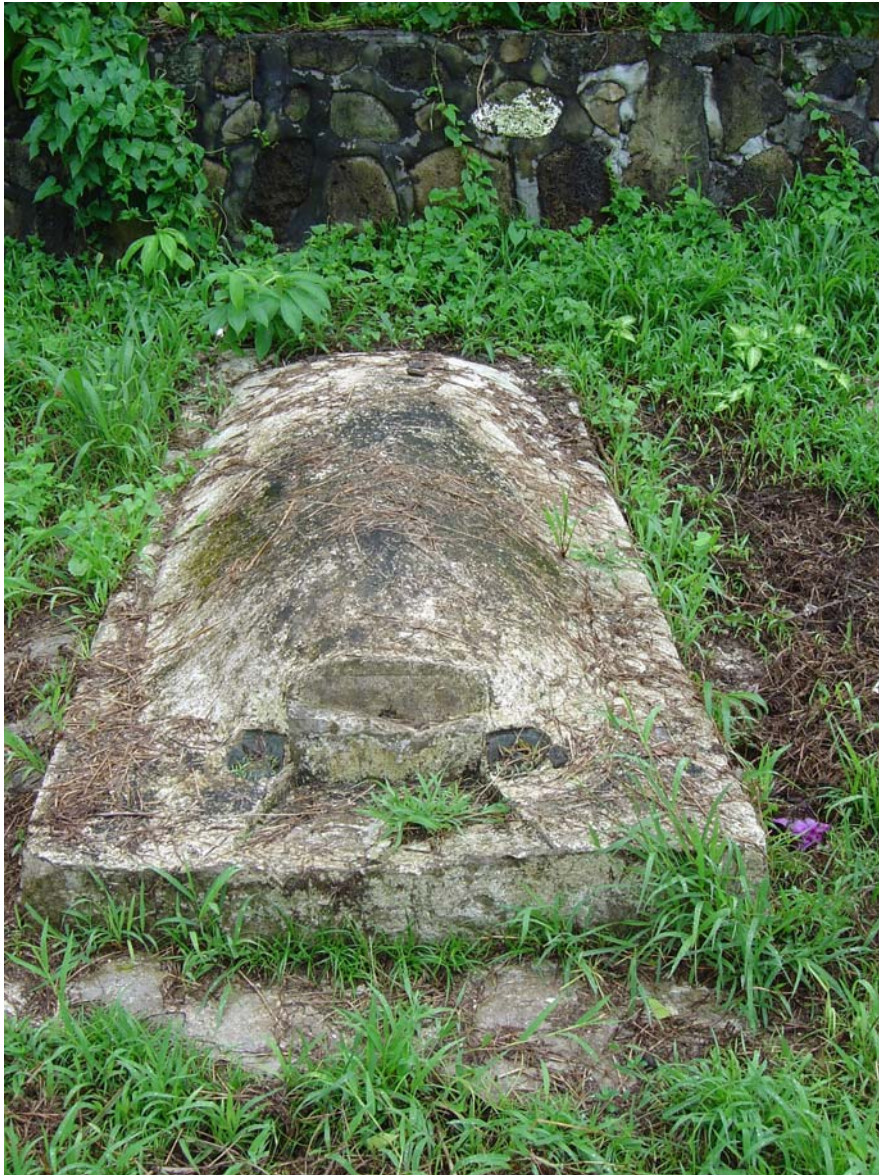
mostly decipherable traces **illegible/destroyed re-carved**

SUMMARY: The primary structure has some small cracks and losses. The grave marker has been broken off and is missing. Two vase stands are also missing. Paint, vegetation and mildew need to be removed.
