CEMETERY SURVEY FORM

SITE NAME: Satala Naval Cemetery

PLOT IDENTIFICATION: 173

NAME(S) OF INTERRED: Ki Bok Kang

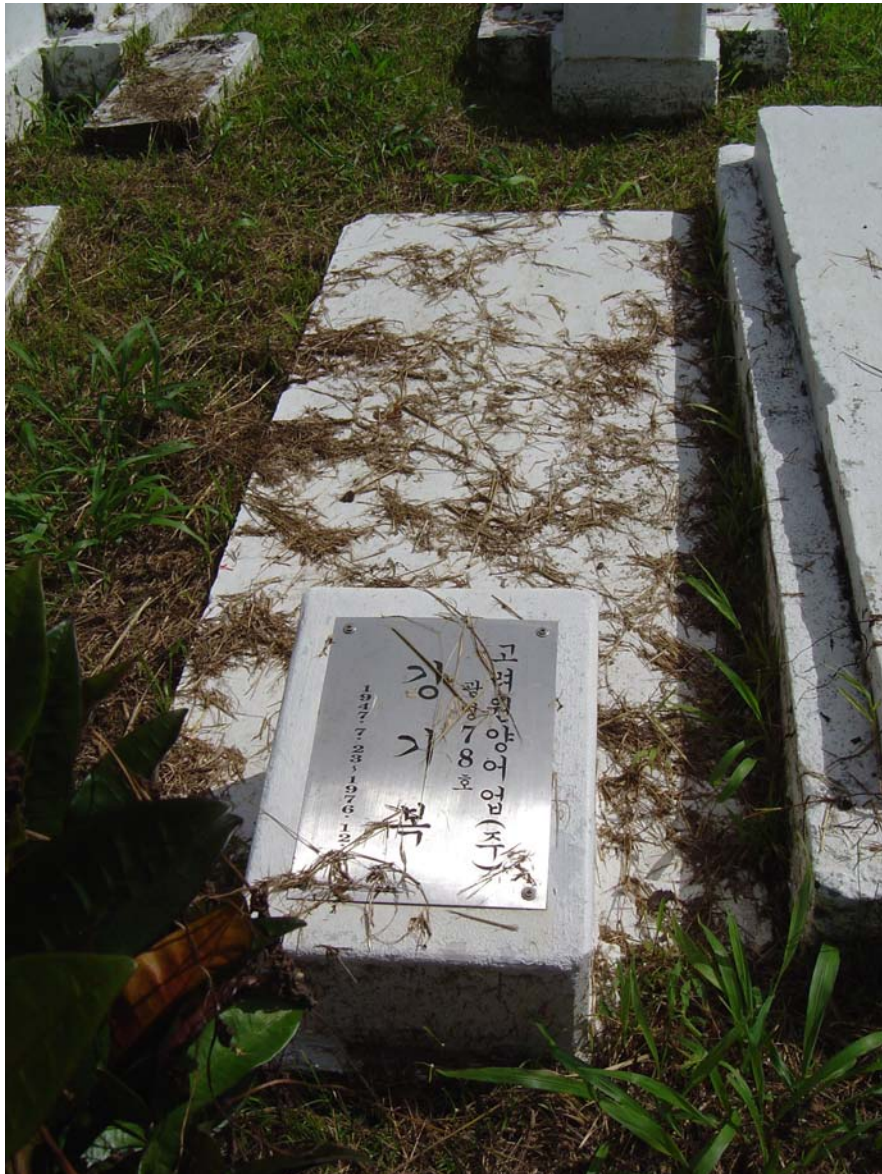
PHOTO:

SUMMARY: Grave is maintained by the American Samoa Korean Association.

Surrounding vegetation occasionally becomes overgrown. No repairs needed.
