CEMETERY SURVEY FORM

SITE NAME: Satala Naval Cemetery

PLOT IDENTIFICATION: 174

NAME(S) OF INTERRED: Hyeo Kun Lee

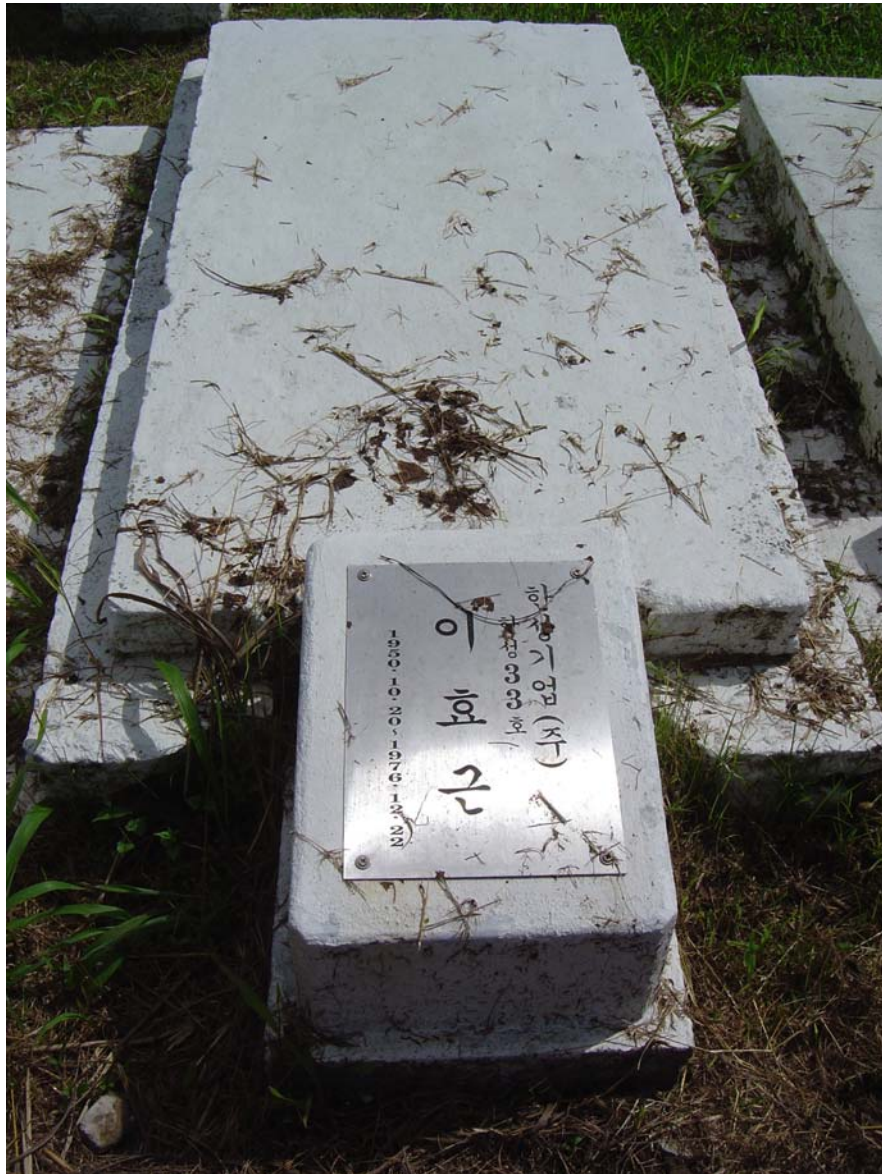
PHOTO:

SUMMARY: Grave is maintained by the American Samoa Korean Association.

Surrounding vegetation occasionally becomes overgrown. No repairs needed.
