# CEMETERY SURVEY FORM

SITE NAME: Satala Naval Cemetery

PLOT IDENTIFICATION: 176

NAME(S) OF INTERRED: Yong Sik Kan

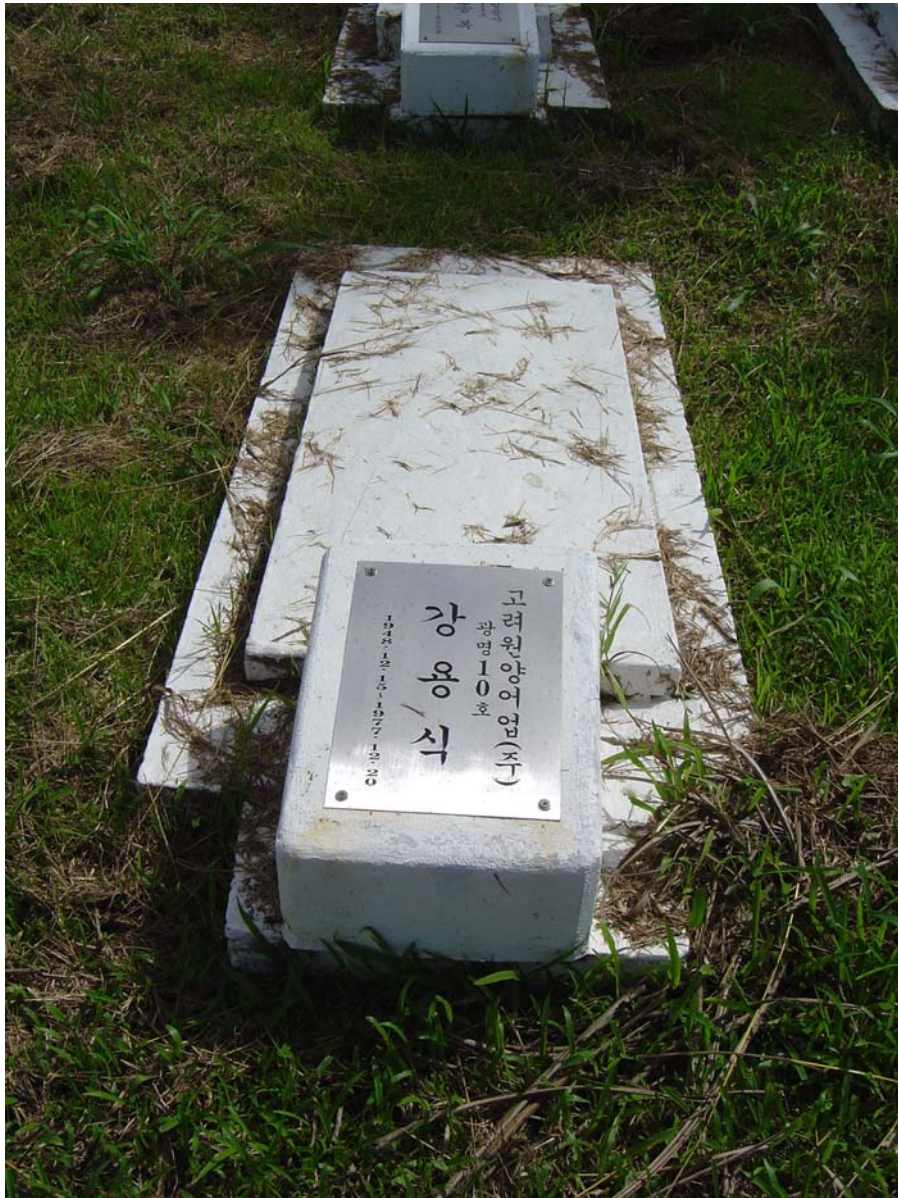
PHOTO:

SUMMARY: Grave is maintained by the American Samoa Korean Association.

Surrounding vegetation occasionally becomes overgrown. No repairs needed.
