# CEMETERY SURVEY FORM

SITE NAME: Satala Naval Cemetery

PLOT IDENTIFICATION: 177

NAME(S) OF INTERRED: Jong Bok Soh

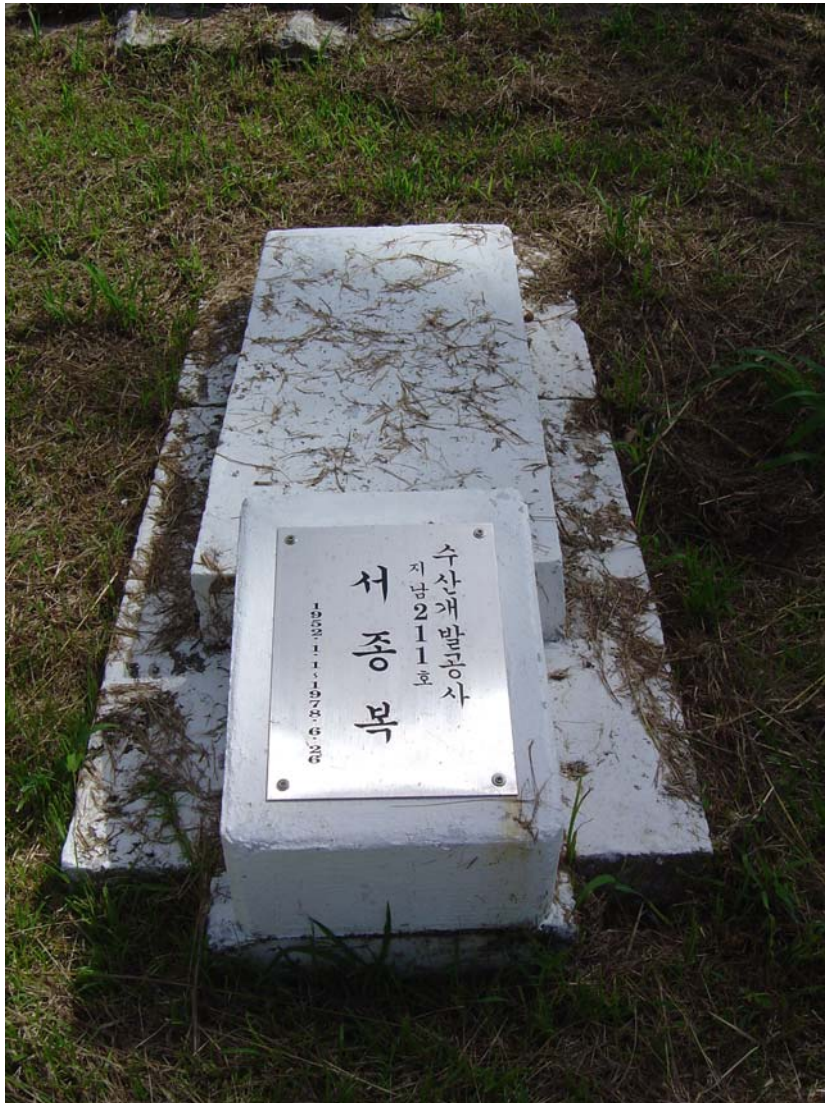
PHOTO:

SUMMARY: Grave is maintained by the American Samoa Korean Association.  
Surrounding vegetation occasionally becomes overgrown. No repairs needed.
