CEMETERY SURVEY FORM

SITE NAME: Satala Naval Cemetery

SURVEYOR: Erika C. Radewagen, M.A. DATE: March 7, 2005

PLOT IDENTIFICATION: 178

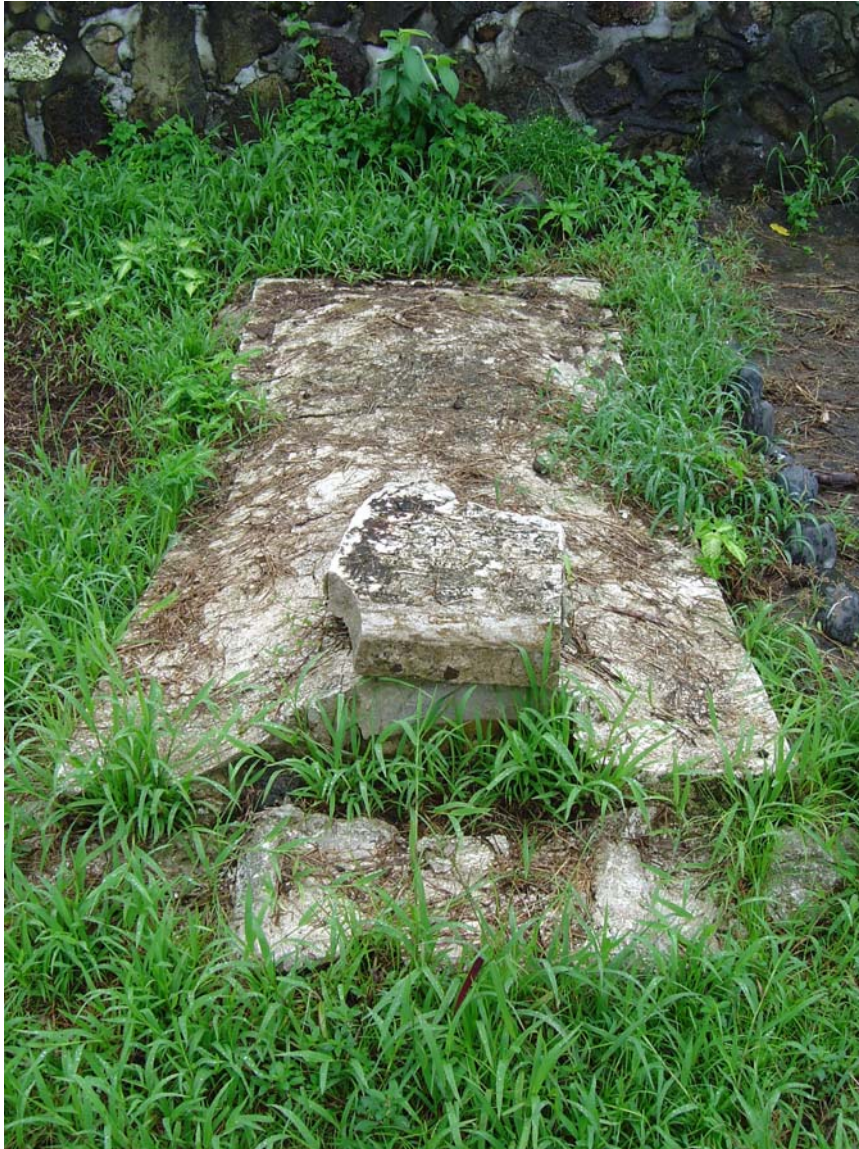
PHOTO:

SUMMARY: The primary structure has some small cracks and losses. The grave marker is broken with one fragment remaining. There is a large hole where the marker was affixed to the primary structure. Paint, vegetation and mildew need to be removed.
