CEMETERY SURVEY FORM

SITE NAME: Satala Naval Cemetery (AS-25-055)

PLOT IDENTIFICATION: 179

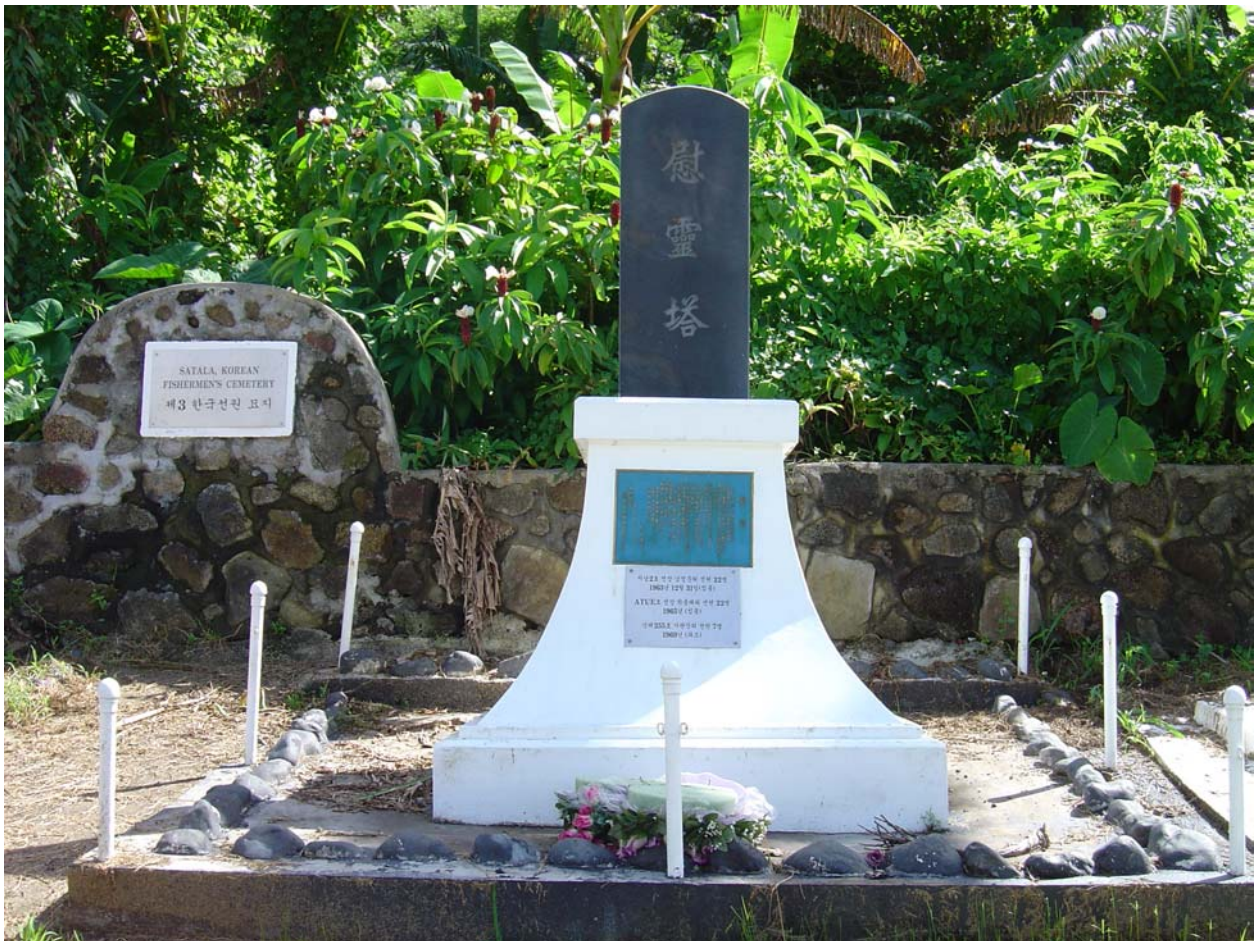
PHOTO:

SUMMARY: Monument erected by American Samoa Korean Association. No repairs needed.
