CEMETERY SURVEY FORM

SITE NAME: Satala Naval Cemetery

LOCATION: Maoputasi County, Tutuila Island, American Samoa

PLOT IDENTIFICATION: 17A

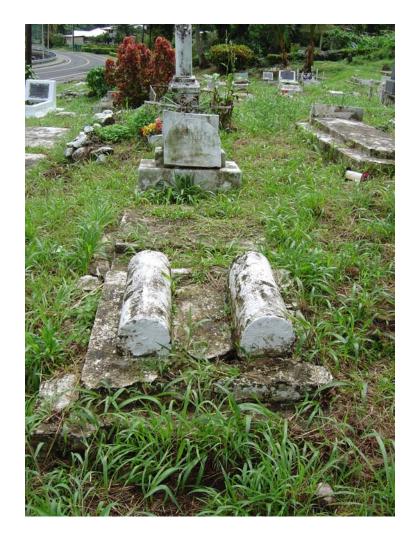
PHOTO:

SUMMARY: Grave may mark child birthing death? Two small loaf casket sculptures. Base is shattered on S edge, primary structure covered in cracks and paint W side of p.s. broken NE side as well.
