CEMETERY SURVEY FORM

SITE NAME: Satala Naval Cemetery

PLOT IDENTIFICATION: 18

NAME(S) OF INTERRED: F. E. SHUTE

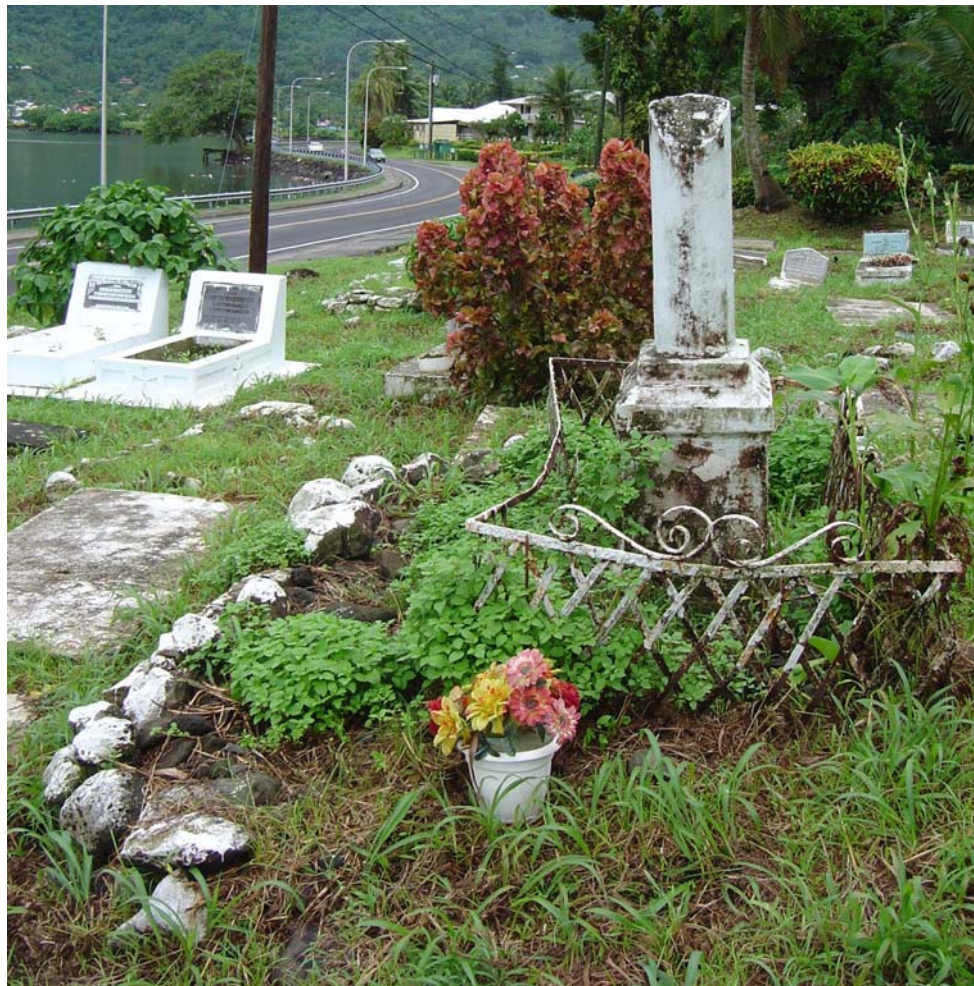
PHOTO:

EXISTING CONDITION	CONSERVATION STRATEGY
<p>POSITION: fallen unstable overgrown tilted marker/ base other <u>collapsing fence</u></p> <p>DETERIORATION: broken cracked losses flaking/sugaring delaminations/detachment other <u>rusting</u></p> <p>SOILING: biological general graffiti efflorescence painting other</p> <p>FAILED TREATMENTS: ----- metal adhesives/coatings mortar other _____</p>	<p>POSITION: reset in ground reset to existing base resquare botom edge remove fragments in setting slot construct new base possible new base required stabilize foundation</p> <p>DETERIORATION: structural adhesion repair mortars crack fillers flowable grouts consolidation</p> <p>SOILING: chemical pressure wash poultice air abrasion</p> <p>FAILED TREATMENTS: drill/grind hand tools solvents air abrasion</p>

SUMMARY: Column broken at 62cm from base, metal plaque facing S covered with paint. Rusted edges, white paint and mildew on entire marker; primary structure is cemented rock outline supporting metal lattice fence, bent, rusty two sides of scrolls and several slats. Base rock platform is overgrown on N side, good condition on S side white paint on some rocks.

hazardous/immediate action **unstable deterioration/ASAP**
