CEMETERY SURVEY FORM

SITE NAME: Satala Naval Cemetery

LOCATION: Maoputasi County, Tutuila Island, American Samoa

PLOT IDENTIFICATION: 180

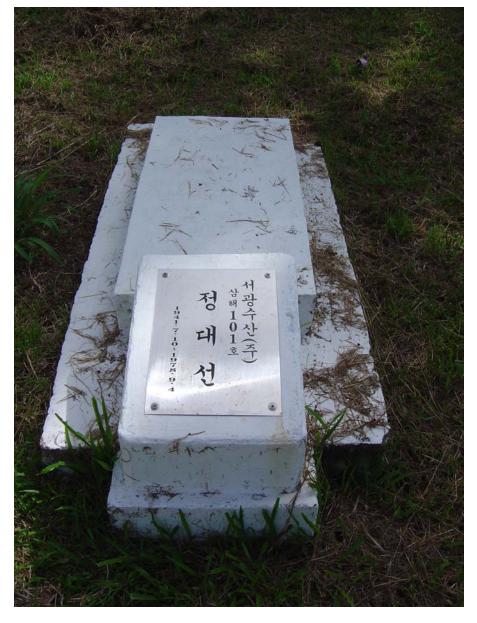
PHOTO:

SUMMARY: Grave is maintained by the American Samoa Korean Association. Surrounding vegetation occasionally becomes overgrown. No repairs needed.
