CEMETERY SURVEY FORM

SITE NAME: Satala Naval Cemetery

PLOT IDENTIFICATION: 181

NAME(S) OF INTERRED: Hyoung Su Lee

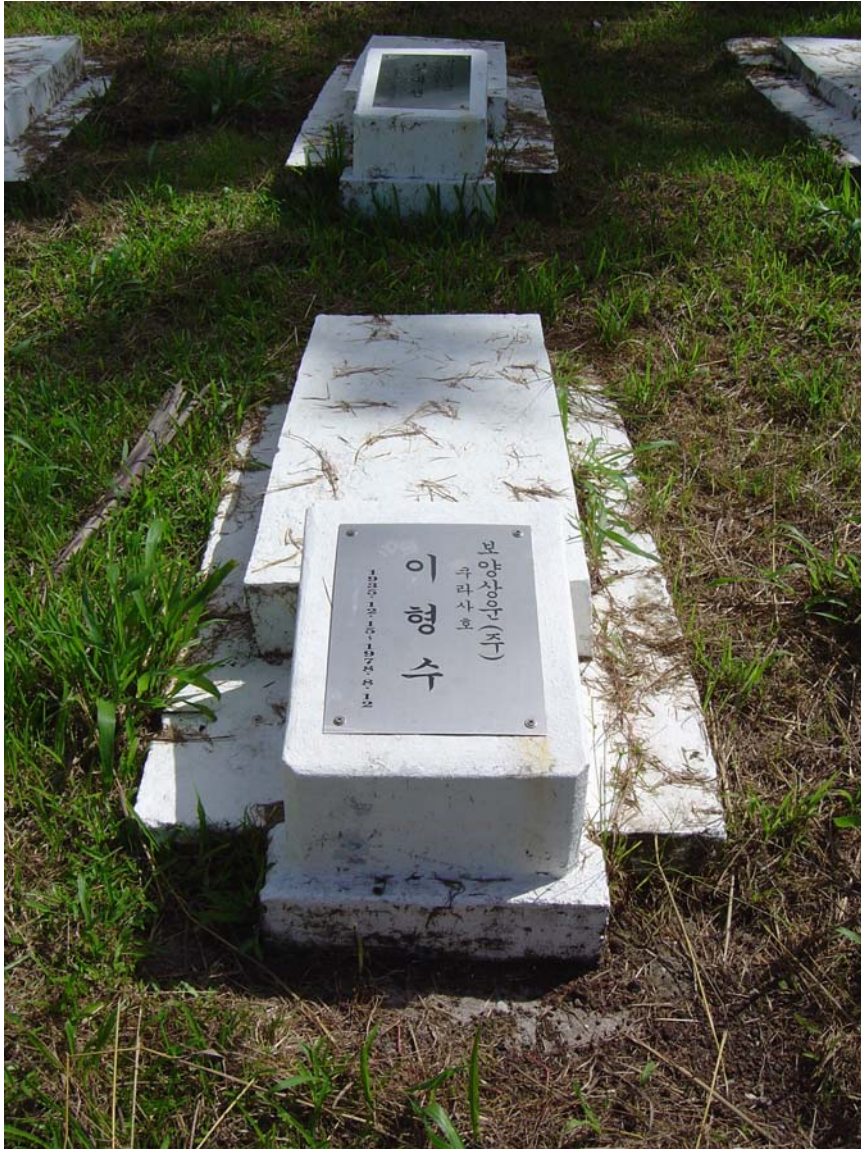
PHOTO:

SUMMARY: Grave is maintained by the American Samoa Korean Association.
Surrounding vegetation occasionally becomes overgrown. No repairs needed.
