CEMETERY SURVEY FORM

SITE NAME: Satala Naval Cemetery

PLOT IDENTIFICATION: 19

NAME(S) OF INTERRED: Mrs. SLAYTON

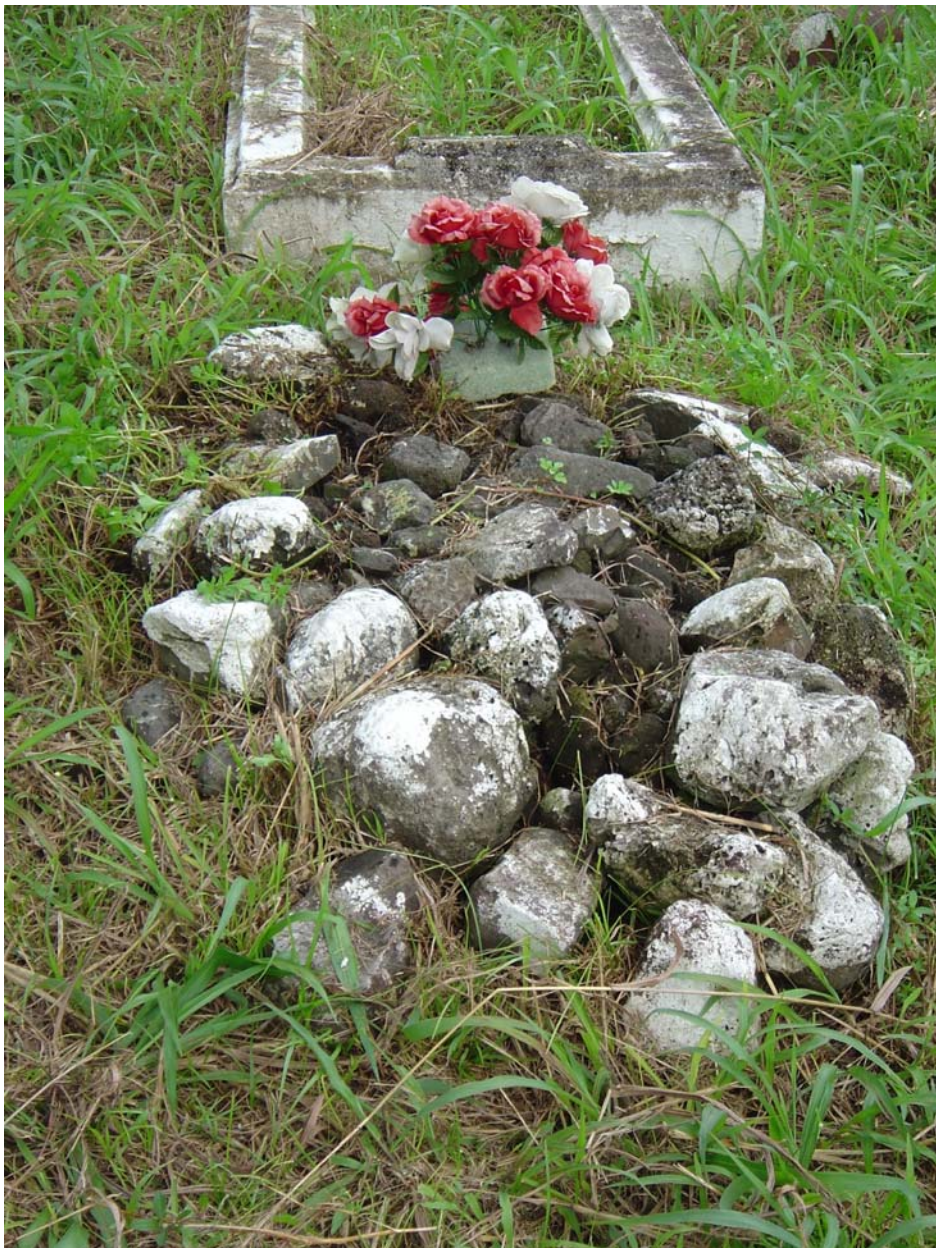
PHOTO:

SUMMARY: Small rock mound overgrown with grass. White paint and mildew on rock.
