CEMETERY SURVEY FORM

SITE NAME: Satala Naval Cemetery

PLOT IDENTIFICATION: 192

NAME(S) OF INTERRED: Ju Man Kim

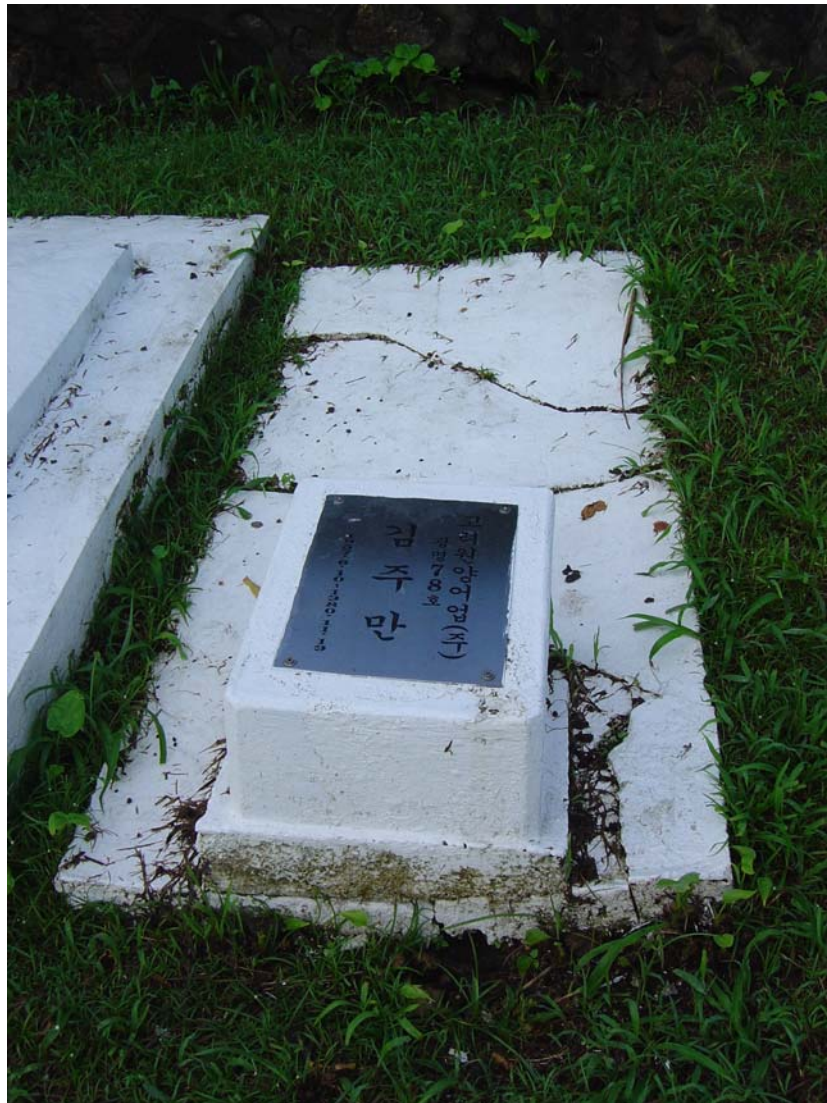
PHOTO:

SUMMARY: Grave is maintained by the American Samoa Korean Association. Surrounding vegetation occasionally becomes overgrown. Primary structure is cracked across in two places. The cracks under the plaque are tilting towards the center.
