CEMETERY SURVEY FORM

SITE NAME: Satala Naval Cemetery

PLOT IDENTIFICATION: 193

NAME(S) OF INTERRED: Kee Sun Yun

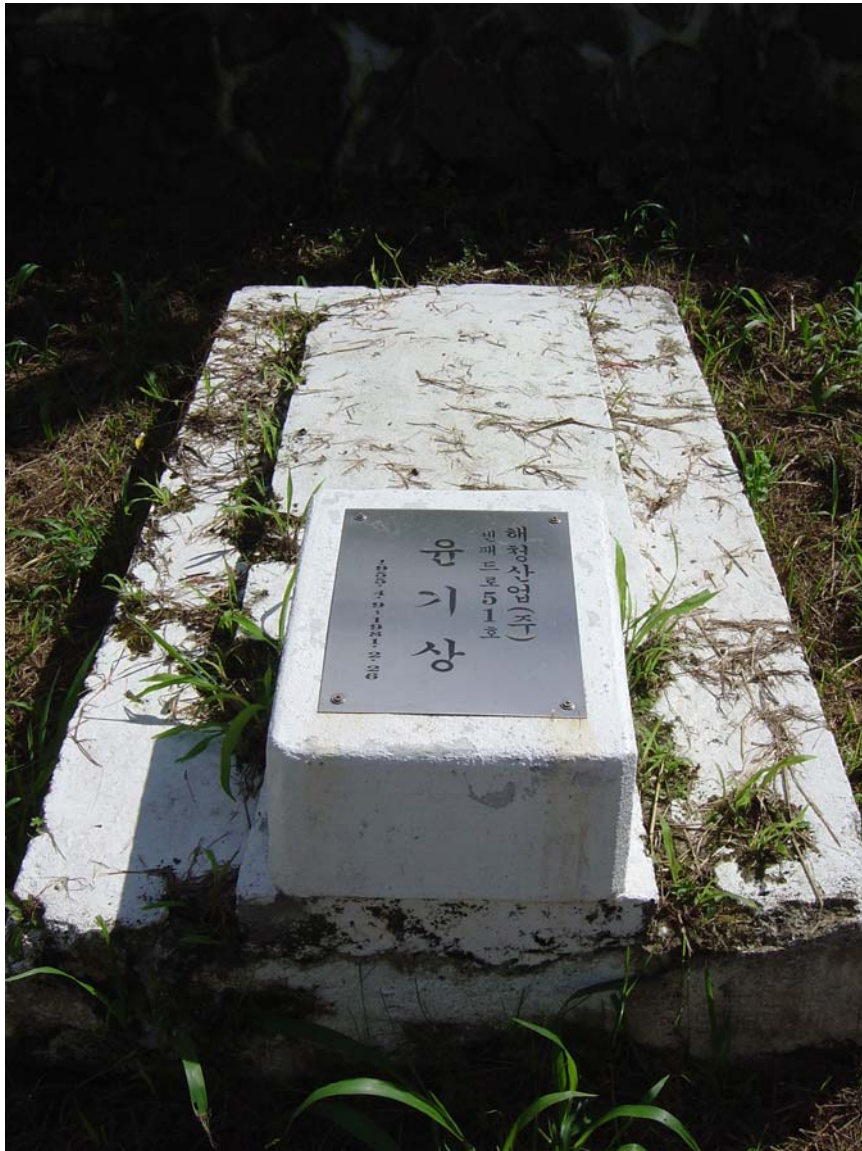
PHOTO:

SUMMARY: Grave is maintained by the American Samoa Korean Association.
Surrounding vegetation occasionally becomes overgrown. No repairs needed.
