CEMETERY SURVEY FORM

SITE NAME: Satala Naval Cemetery (AS-25-055)

PLOT IDENTIFICATION: 197

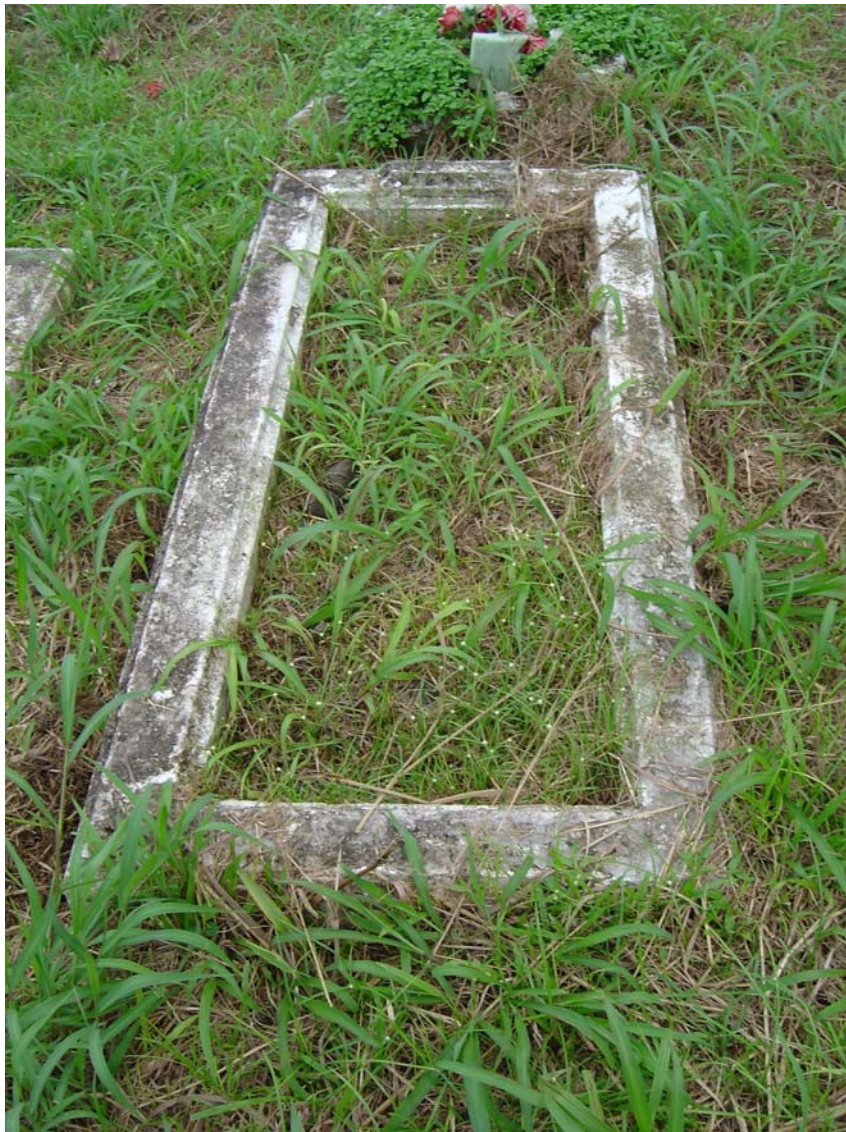
PHOTO:

SUMMARY: Base for headstone intact; open bedstead filled with basalt cobbles. Paint and mildew cover grave.
