# CEMETERY SURVEY FORM

SITE NAME: Satala Naval Cemetery

LOCATION: Maoputasi County, Tutuila Island, American Samoa

PLOT IDENTIFICATION: 199

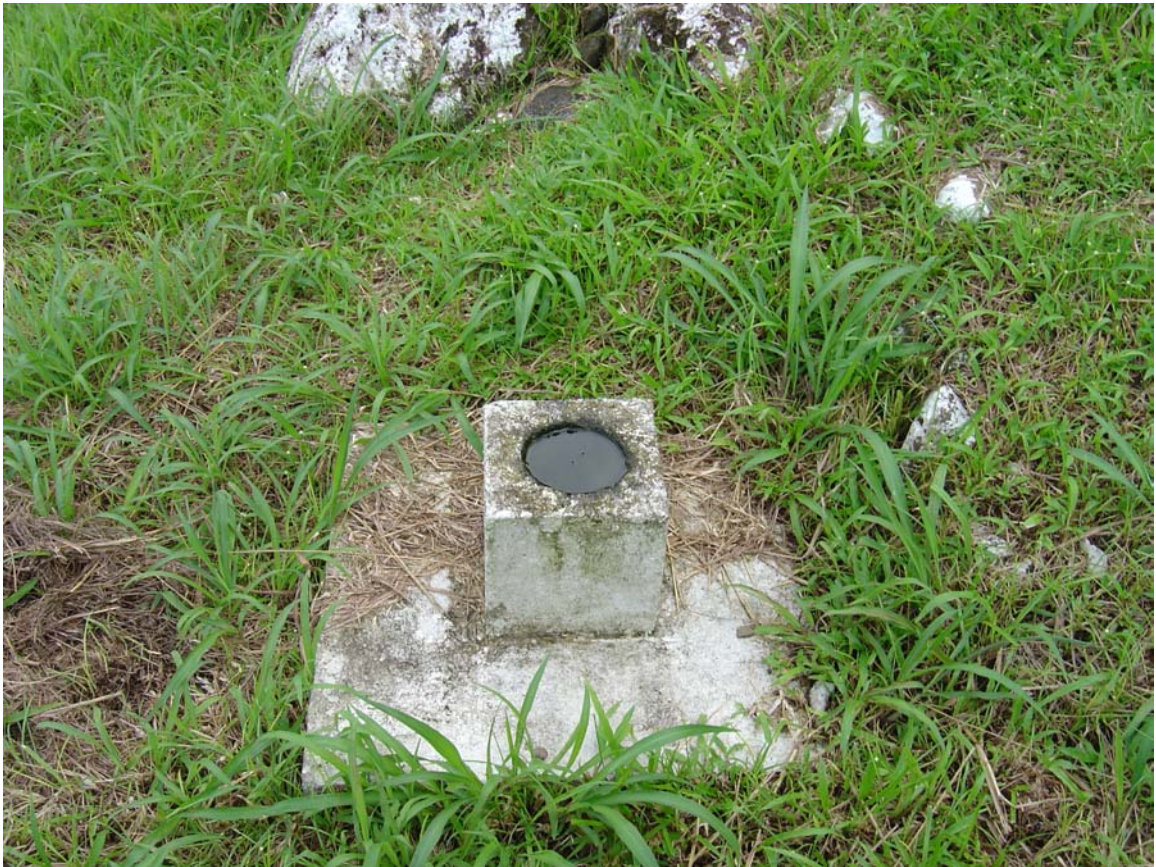
PHOTO:

EXISTING CONDITION	CONSERVATION STRATEGY
<p>POSITION: fallen unstable <b>overgrown</b> <b>tilted marker/ base</b> other _____</p> <p>DETERIORATION: broken cracked losses flaking/sugaring delaminations/detachment other <u>rusting</u></p> <p>SOILING: <b>biological</b> general graffiti efflorescence <b>painting</b> other</p> <p>FAILED TREATMENTS: ----- metal adhesives/coatings mortar other _____</p>	<p>POSITION: reset in ground reset to existing base resquare botom edge remove fragments in setting slot construct new base possible new base required stabilize foundation</p> <p>DETERIORATION: structural adhesion repair mortars crack fillers flowable grouts consolidation</p> <p>SOILING: chemical pressure wash poultice air abrasion</p> <p>FAILED TREATMENTS: drill/grind hand tools solvents air abrasion</p>

SUMMARY: Small concrete marker with possible vase stand. Marker may have been moved from original location. Paint and mildew need to be removed.
