# CEMETERY SURVEY FORM

SITE NAME: Satala Naval Cemetery

PLOT IDENTIFICATION: 20

NAME(S) OF INTERRED: Mrs. ANNAHARRINGTON

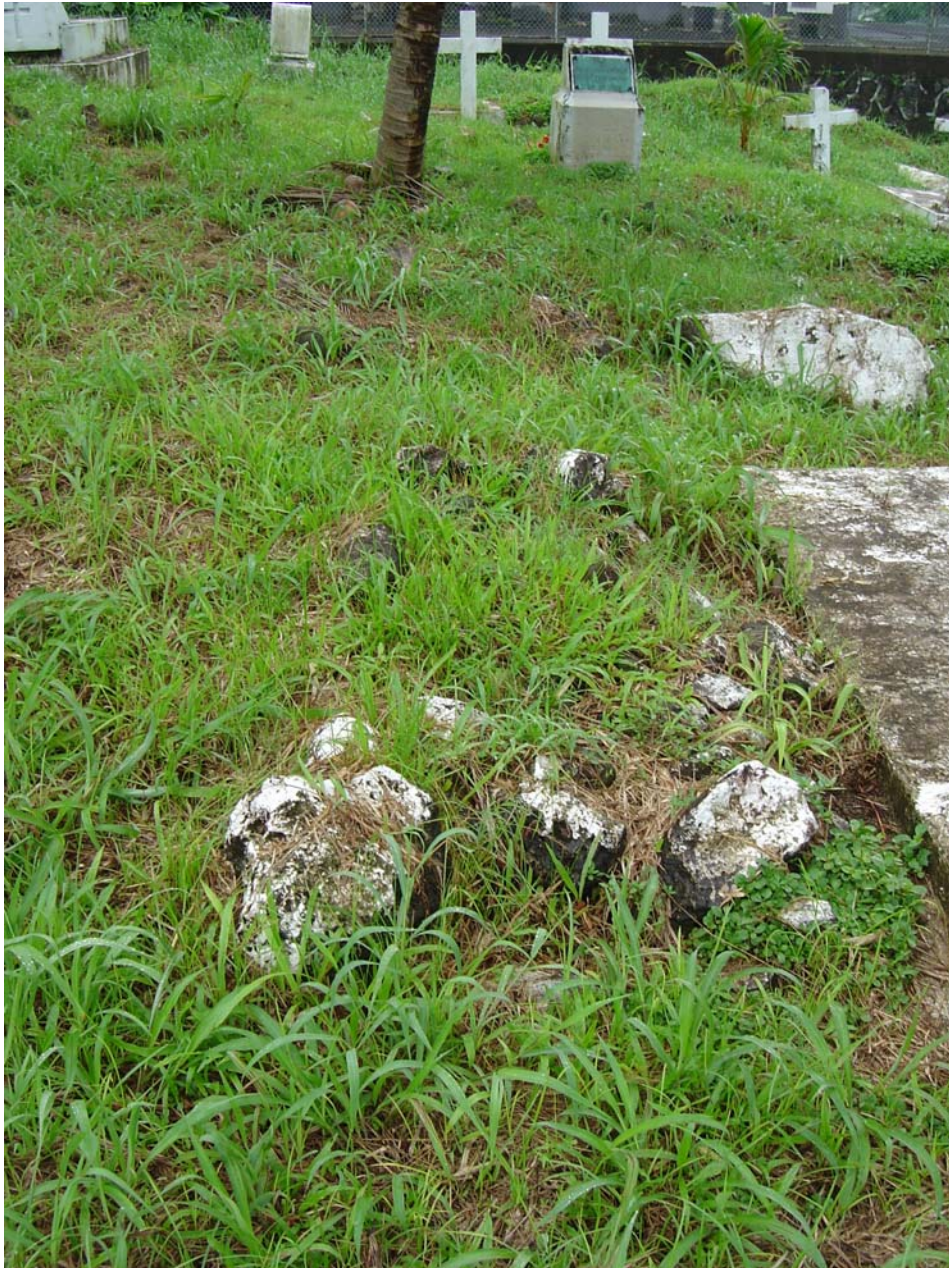
PHOTO:

| EXISTING CONDITION | CONSERVATION STRATEGY |
|---|--|
| <p>POSITION:<br/>fallen unstable <b>overgrown</b><br/>tilted marker/ base other _____</p> <p>DETERIORATION: ---<br/>broken cracked losses flaking/sugaring<br/>delaminations/detachment<br/>other <u>rusting</u></p> <p>SOILING:<br/><b>biological</b> general graffiti efflorescence<br/><b>painting</b> other</p> <p>FAILED TREATMENTS: ---<br/>metal adhesives/coatings mortar<br/>other _____</p> | <p>POSITION:<br/>reset in ground<br/>reset to existing base<br/>resquare botom edge<br/>remove fragments in setting slot<br/>construct new base<br/>possible new base required<br/>stabilize foundation</p> <p>DETERIORATION:<br/>structural adhesion repair mortars<br/>crack fillers flowable grouts<br/>consolidation</p> <p>SOILING:<br/>chemical pressure wash<br/>poultice air abrasion</p> <p>FAILED TREATMENTS:<br/>drill/grind hand tools solvents<br/>air abrasion</p> |

**ongoing deterioration/treatment required 2-5 years**    re-inspect in 5 years

SUMMARY: Overgrown rock mound with white paint on visible rocks.
