CEMETERY SURVEY FORM

SITE NAME: Satala Naval Cemetery

LOCATION: Maoputasi County, Tutuila Island, American Samoa

PLOT IDENTIFICATION: 200

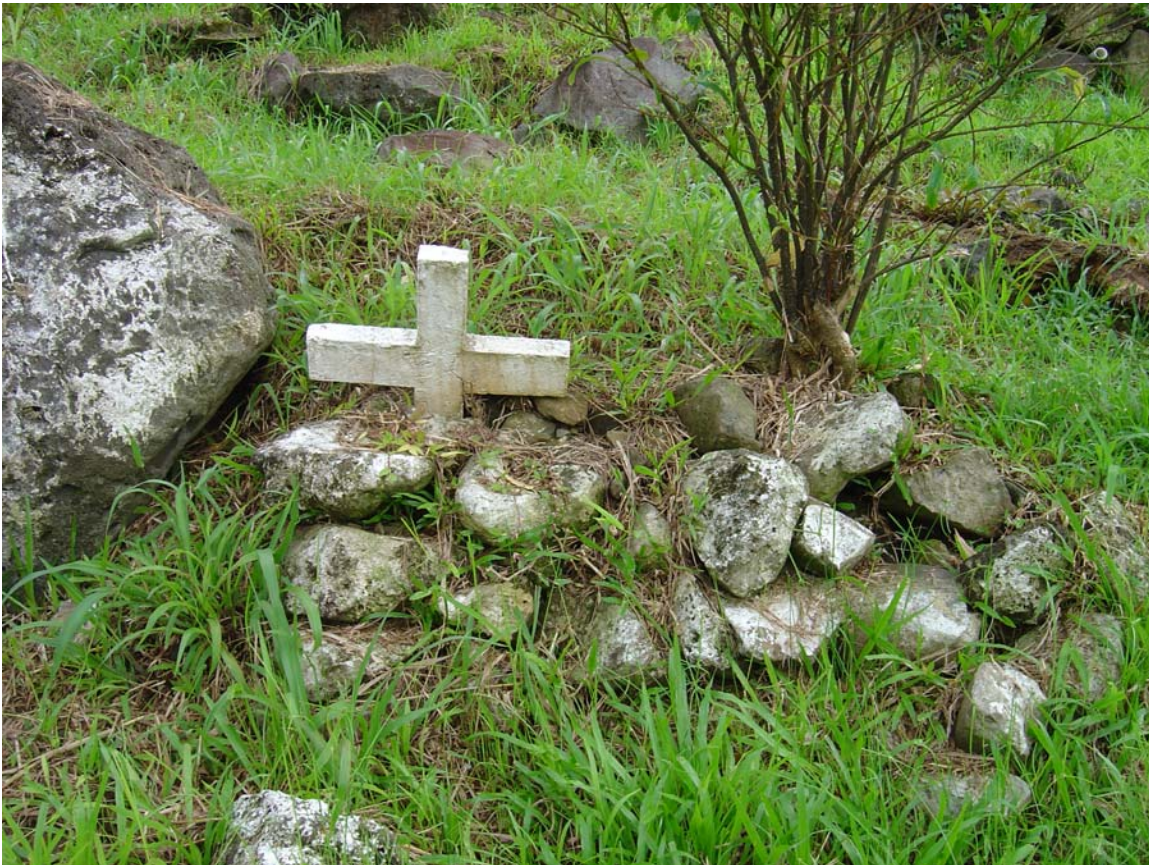
PHOTO:

EXISTING CONDITION	CONSERVATION STRATEGY
<p>POSITION: fallen unstable overgrown tilted marker/ base other _____</p> <p>DETERIORATION: broken cracked losses flaking/sugaring delaminations/detachment other <u>rusting</u></p> <p>SOILING: biological general graffiti efflorescence painting other</p> <p>FAILED TREATMENTS: ----- metal adhesives/coatings mortar other _____</p>	<p>POSITION: reset in ground reset to existing base resquare botom edge remove fragments in setting slot construct new base possible new base required stabilize foundation</p> <p>DETERIORATION: structural adhesion repair mortars crack fillers flowable grouts consolidation</p> <p>SOILING: chemical pressure wash poultice air abrasion</p> <p>FAILED TREATMENTS: drill/grind hand tools solvents air abrasion</p>

SUMMARY: Cross may have been moved from original location has illegible inscription on it. Paint and mildew need to be removed. Grave may not be grave.
