# CEMETERY SURVEY FORM

SITE NAME: Satala Naval Cemetery

PLOT IDENTIFICATION: 21

NAME(S) OF INTERRED: L. DeGrace

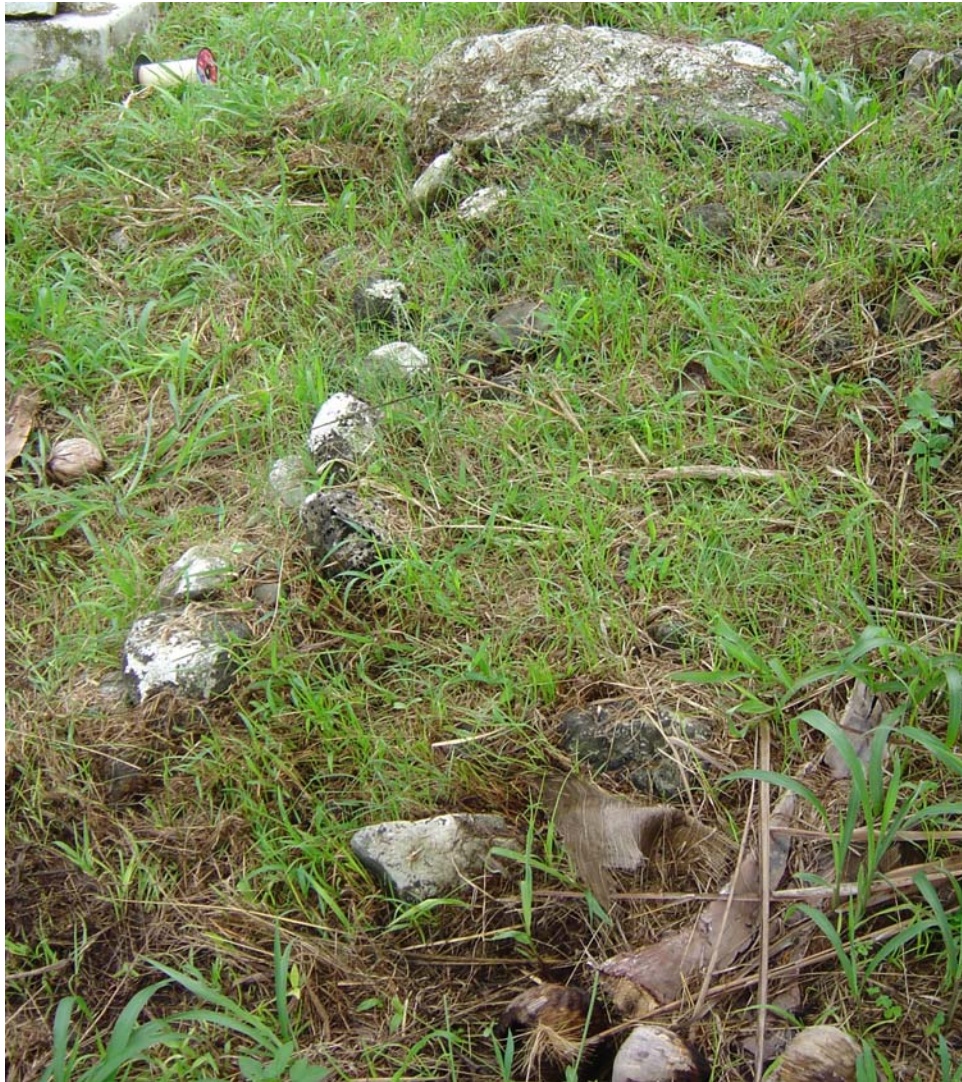
PHOTO:

SUMMARY: White paint covers possible headstone on S edge of grave; entire grave is overgrown.
