# CEMETERY SURVEY FORM

SITE NAME: Satala Naval Cemetery

LOCATION: Maoputasi County, Tutuila Island, American Samoa

PLOT IDENTIFICATION: 23

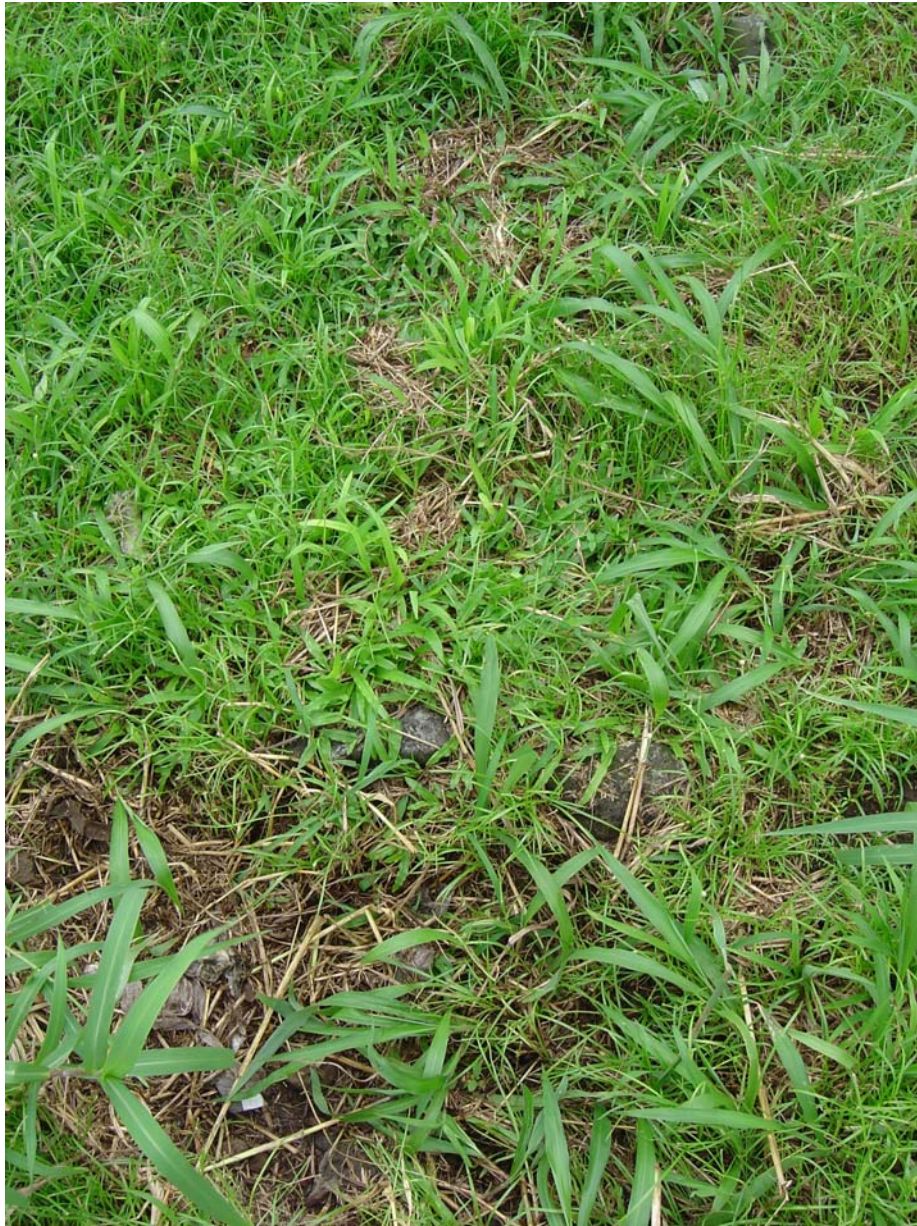
PHOTO:

EXISTING CONDITION	CONSERVATION STRATEGY
<p>POSITION: fallen unstable <b>overgrown</b> tilted marker/ base other _____</p> <p>DETERIORATION: ----- broken cracked losses flaking/sugaring delaminations/detachment other _____</p> <p>SOILING: <b>biological</b> general graffiti efflorescence <b>painting</b> other</p> <p>FAILED TREATMENTS: ----- metal adhesives/coatings mortar other _____</p>	<p>POSITION: reset in ground reset to existing base resquare botom edge remove fragments in setting slot construct new base possible new base required stabilize foundation</p> <p>DETERIORATION: structural adhesion repair mortars crack fillers flowable grouts consolidation</p> <p>SOILING: chemical pressure wash poultice air abrasion</p> <p>FAILED TREATMENTS: drill/grind hand tools solvents air abrasion</p>

SUMMARY: Overgrown almost completely. Few visible rocks, some painted white.

hazardous/immediate action **unstable deterioration/ASAP**
