# CEMETERY SURVEY FORM

SITE NAME: Satala Naval Cemetery

PLOT IDENTIFICATION: 24

NAME(S) OF INTERRED: R. Okener

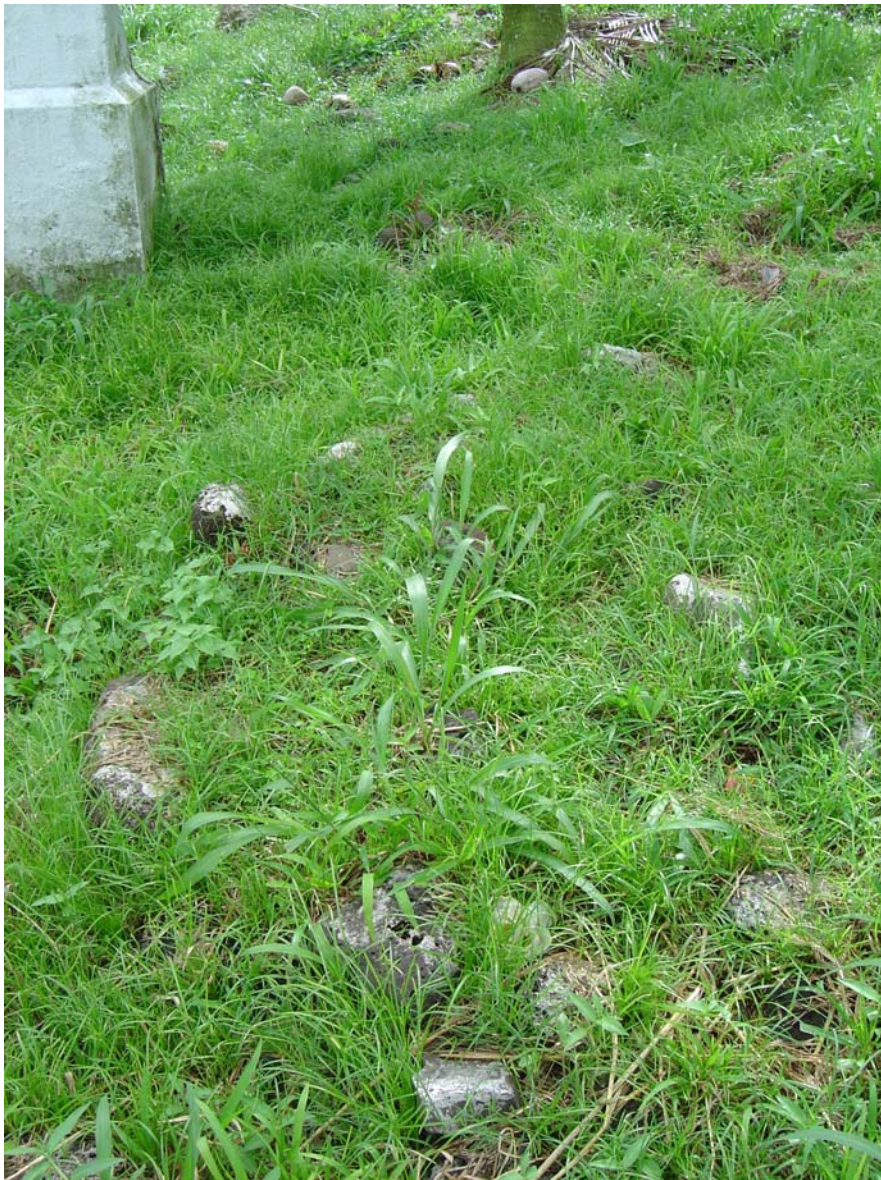
PHOTO:

EXISTING CONDITION	CONSERVATION STRATEGY
<p>POSITION:</p> <p><b>fallen</b> unstable <b>overgrown</b></p> <p>tilted marker/ base other _____</p> <p>DETERIORATION: -----</p> <p>broken cracked losses flaking/sugaring delaminations/detachment other _____</p> <p>SOILING:</p> <p><b>biological</b> general graffiti efflorescence <b>painting</b> other</p> <p>FAILED TREATMENTS: -----</p> <p>metal adhesives/coatings mortar other _____</p>	<p>POSITION:</p> <p>reset in ground</p> <p>reset to existing base</p> <p>resquare botom edge</p> <p>remove fragments in setting slot</p> <p>construct new base</p> <p>possible new base required</p> <p>stabilize foundation</p> <p>DETERIORATION:</p> <p>structural adhesion repair mortars crack fillers flowable grouts consolidation</p> <p>SOILING:</p> <p>chemical pressure wash poultice air abrasion</p> <p>FAILED TREATMENTS:</p> <p>drill/grind hand tools solvents air abrasion</p>

SUMMARY: Overgrown plot needs weeding; may have unstable E edge due to undercutting during flood 2003.
