CEMETERY SURVEY FORM

SITE NAME: Satala Naval Cemetery

PLOT IDENTIFICATION: 25

NAME(S) OF INTERRED: J. P. PURDON

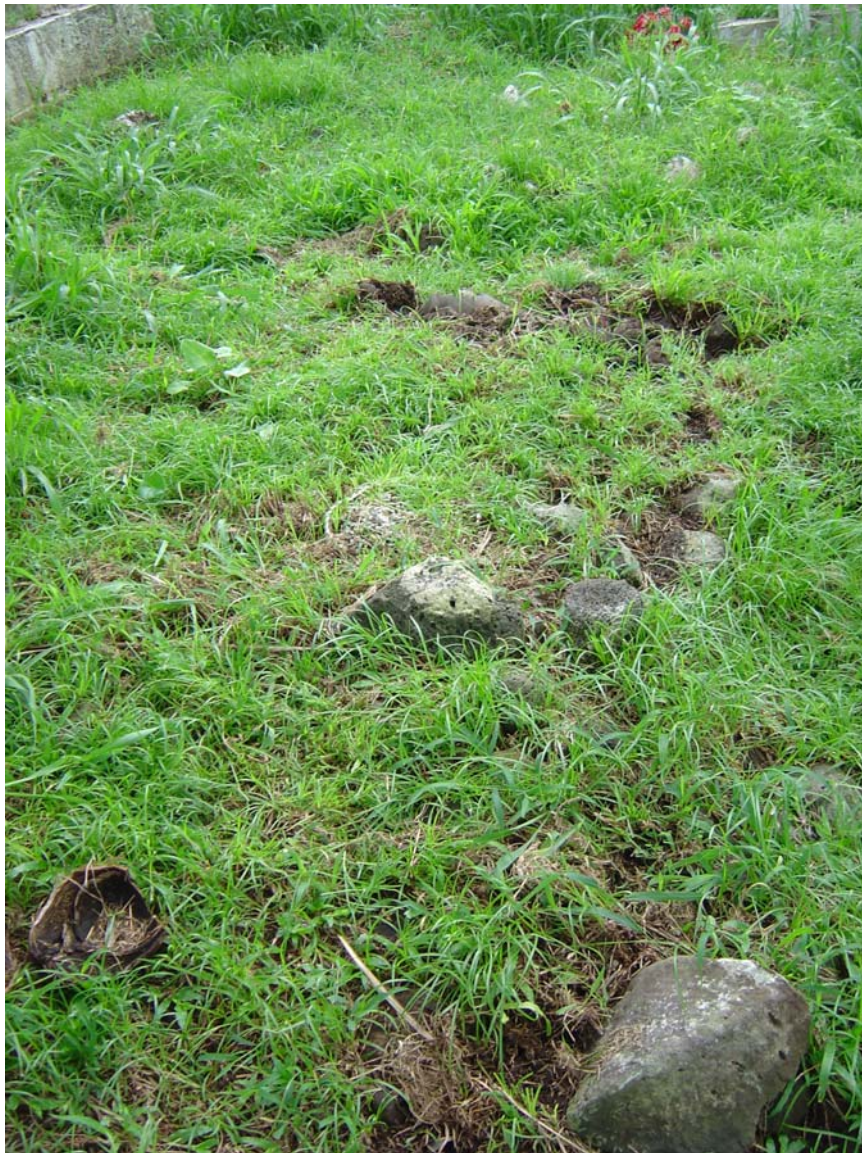
PHOTO:

hazardous/immediate action **unstable deterioration/ASAP**

SUMMARY: DIFFUSE rock mound/outline. Partially visible, too overgrown to identify; possible erosion from Flood 2003.
