CEMETERY SURVEY FORM

SITE NAME: Satala Naval Cemetery

LOCATION: Maoputasi County, Tutuila Island, American Samoa

PLOT IDENTIFICATION: 27

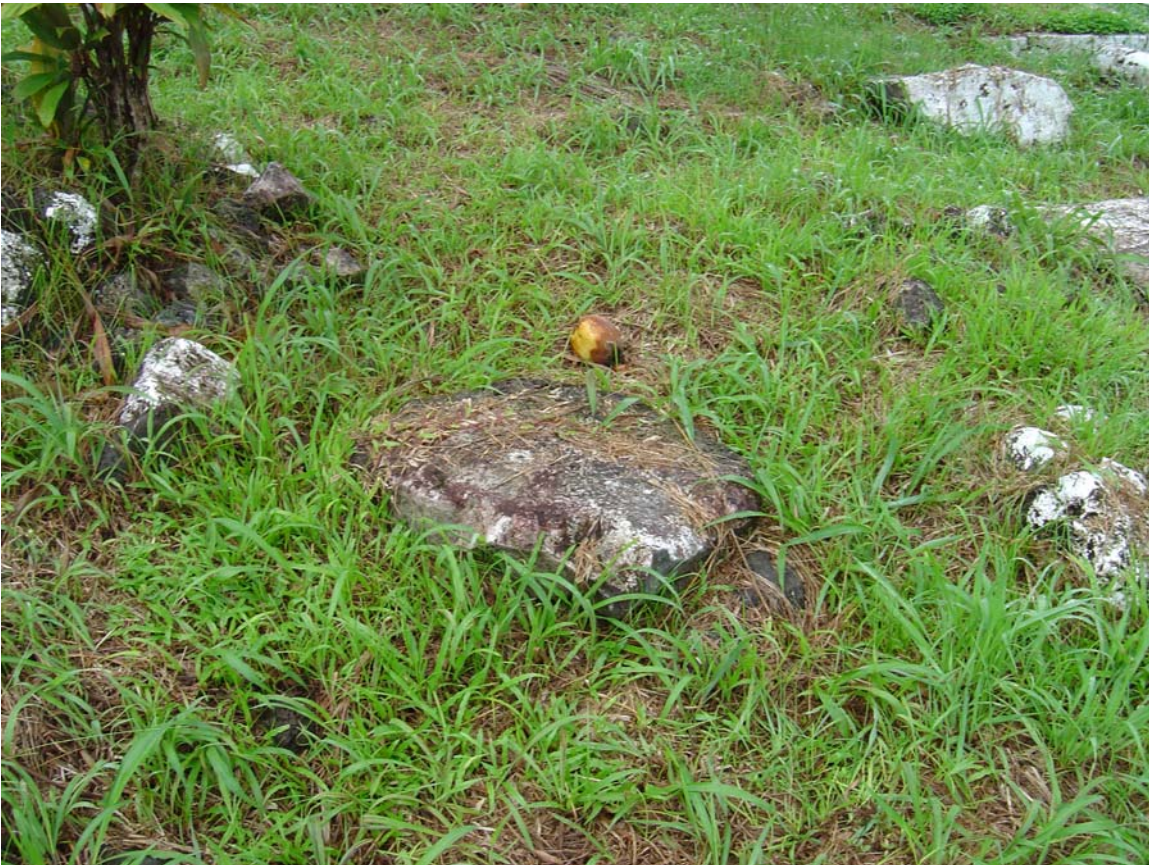
PHOTO:

EXISTING CONDITION	CONSERVATION STRATEGY
<p>POSITION: fallen unstable overgrown tilted marker/ base other _____</p> <p>DETERIORATION: ----- broken cracked losses flaking/sugaring delaminations/detachment other <u>rusting</u></p> <p>SOILING: biological general graffiti efflorescence painting other</p> <p>FAILED TREATMENTS: ----- metal adhesives/coatings mortar other _____</p>	<p>POSITION: reset in ground reset to existing base resquare botom edge remove fragments in setting slot construct new base possible new base required stabilize foundation</p> <p>DETERIORATION: structural adhesion repair mortars crack fillers flowable grouts consolidation</p> <p>SOILING: chemical pressure wash poultice air abrasion</p> <p>FAILED TREATMENTS: drill/grind hand tools solvents air abrasion</p>

SUMMARY: Basalt boulder covered in white paint and mildew.

ongoing deterioration/treatment required 2-5 years **re-inspect in 5 years**
