CEMETERY SURVEY FORM

SITE NAME: Satala Naval Cemetery

LOCATION: Maoputasi County, Tutuila Island, American Samoa

PLOT IDENTIFICATION: 3

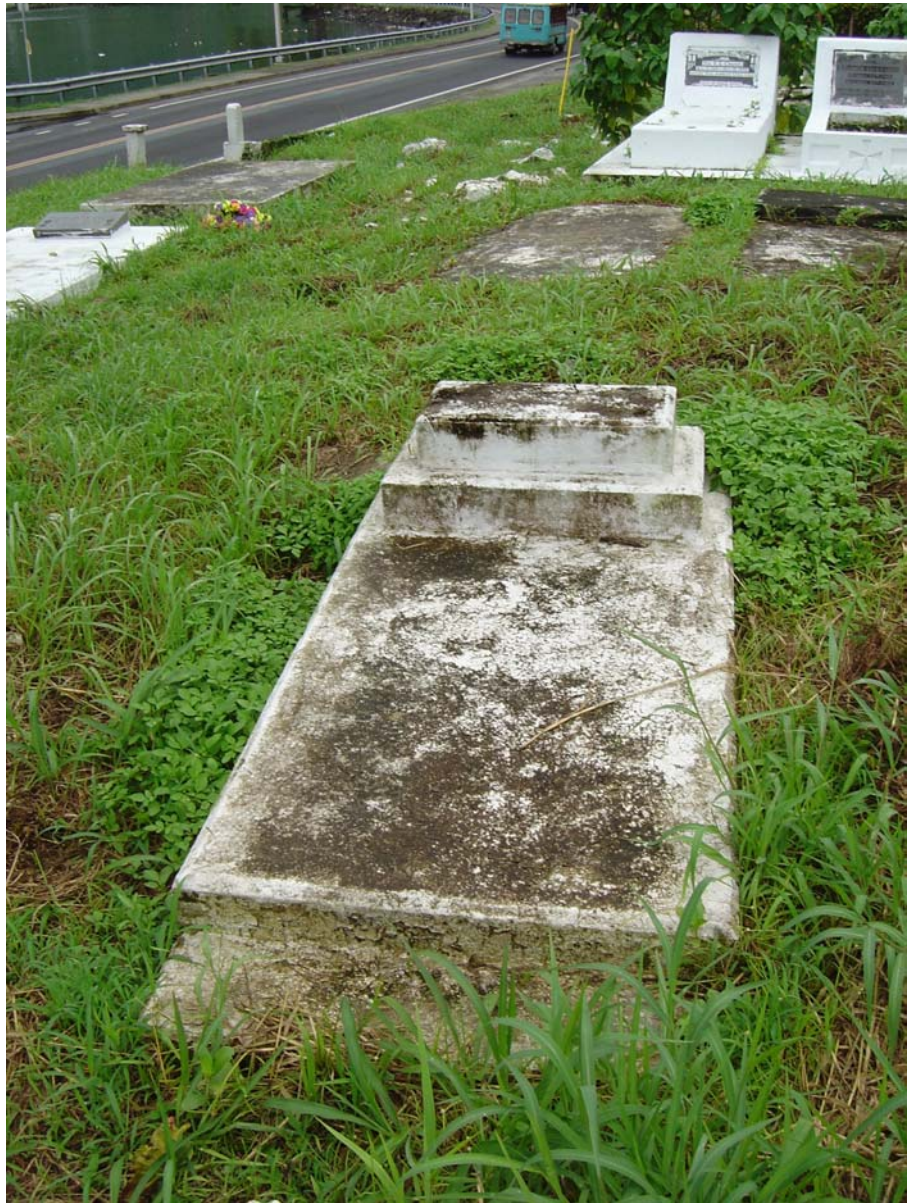
PHOTO:

SUMMARY: Possible missing marker/sculpture on top; entire tomb covered in thick white paint and mildew.

ongoing deterioration/treatment required 2-5 years **re-inspect in 5 years**
