CEMETERY SURVEY FORM

SITE NAME: Satala Naval Cemetery

LOCATION: Maoputasi County, Tutuila Island, American Samoa

PLOT IDENTIFICATION: 30

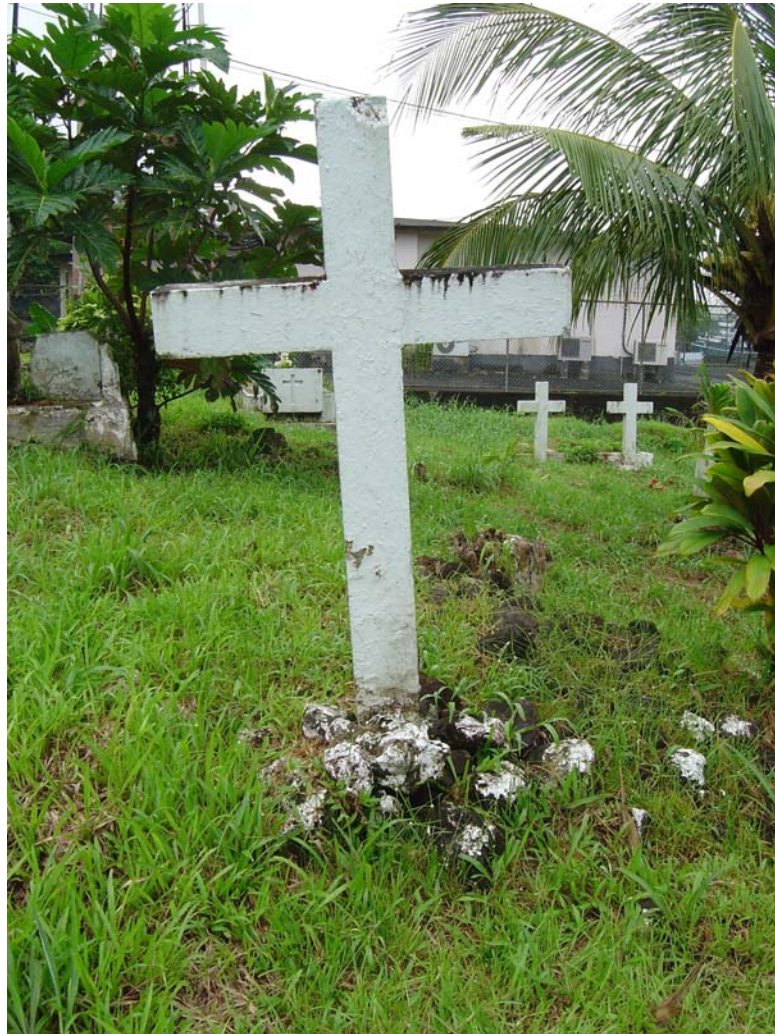
PHOTO:

hazardous/immediate action **unstable deterioration/ASAP**

SUMMARY: Large rock mound overgrown with some painted rocks, looks altered but no way of checking; large white painted cross tilted and unstable covered in latex paint and mildew, some chipping and flaking on exposed concrete.
