CEMETERY SURVEY FORM

SITE NAME: Satala Naval Cemetery

PLOT IDENTIFICATION: 31

NAME(S) OF INTERRED: C. CORDTS

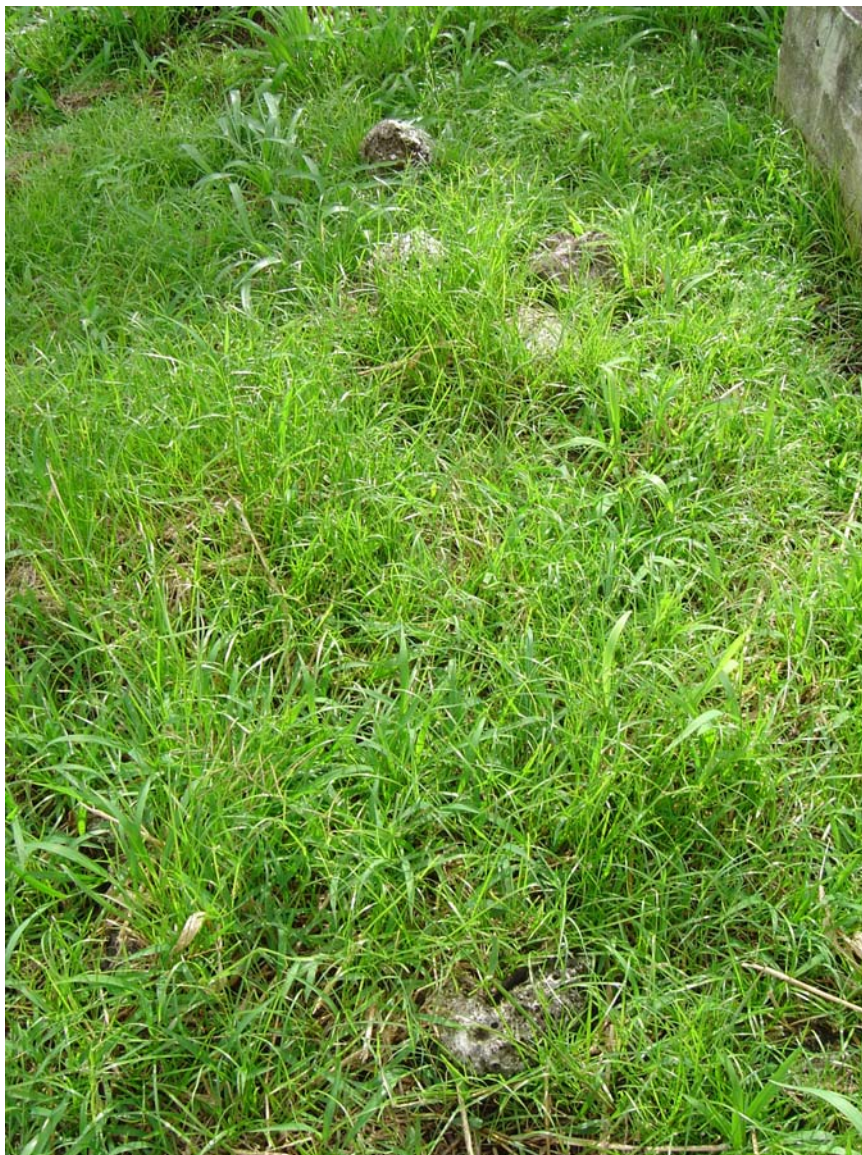
PHOTO:

hazardous/immediate action **unstable deterioration/ASAP**

SUMMARY: Some painted rocks; NW corner may be sliding, overgrown in need of weeding.
