CEMETERY SURVEY FORM

SITE NAME: Satala Naval Cemetery

LOCATION: Maoputasi County, Tutuila Island, American Samoa

PLOT IDENTIFICATION: 33

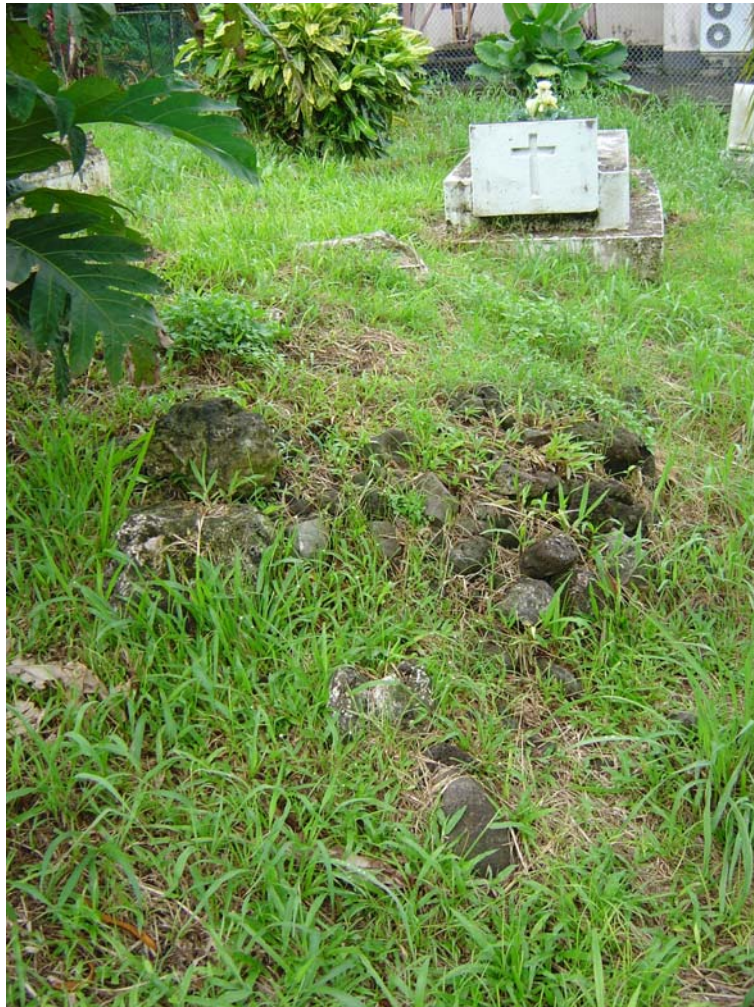
PHOTO:

hazardous/immediate action **unstable deterioration/ASAP**

SUMMARY: Rock mound approximately three courses high overgrown; slumping W side some rocks painted white; large white painted boulder on E side; some coral frags in surface paving; large coral boulder on W side.
