CEMETERY SURVEY FORM

SITE NAME: Satala Naval Cemetery

LOCATION: Maoputasi County, Tutuila Island, American Samoa

PLOT IDENTIFICATION: 34

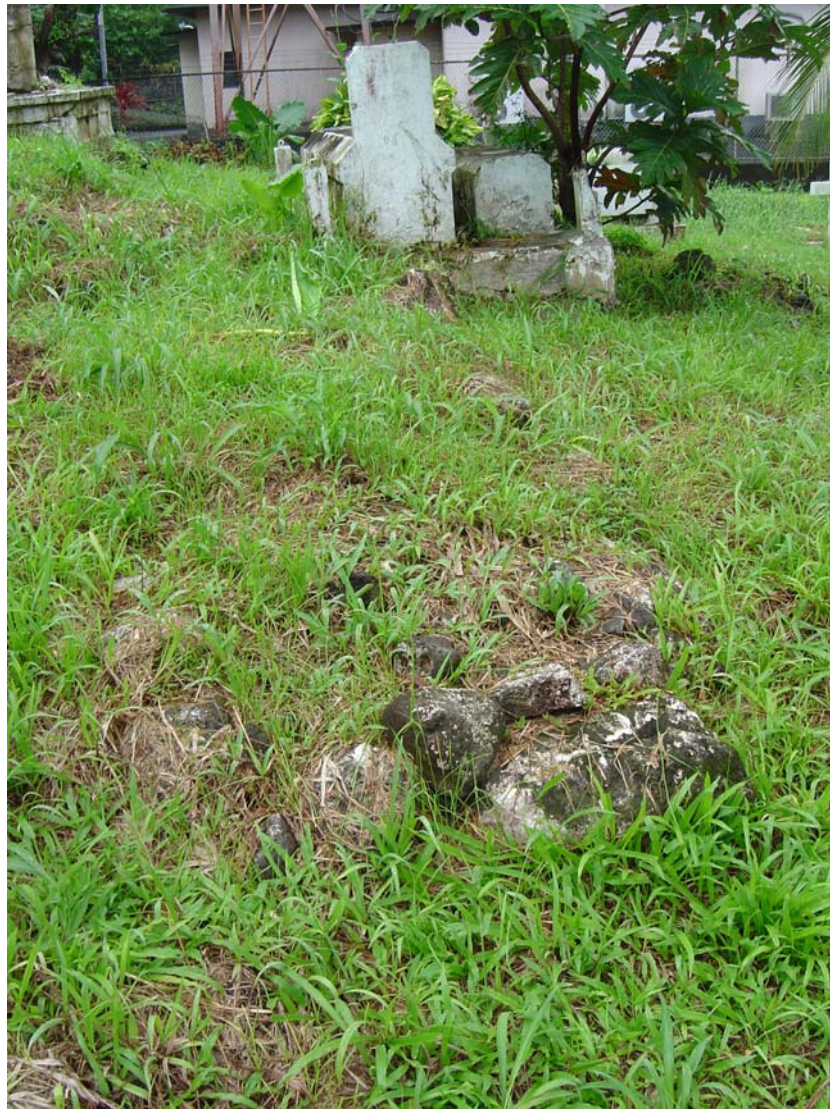
PHOTO:

SUMMARY: Oblong basalt rock mound with core fill; base rocks covered in white paint and moss; entire grave overgrown but mostly visible.
