# CEMETERY SURVEY FORM

SITE NAME: Satala Naval Cemetery

LOCATION: Maoputasi County, Tutuila Island, American Samoa

PLOT IDENTIFICATION: 35

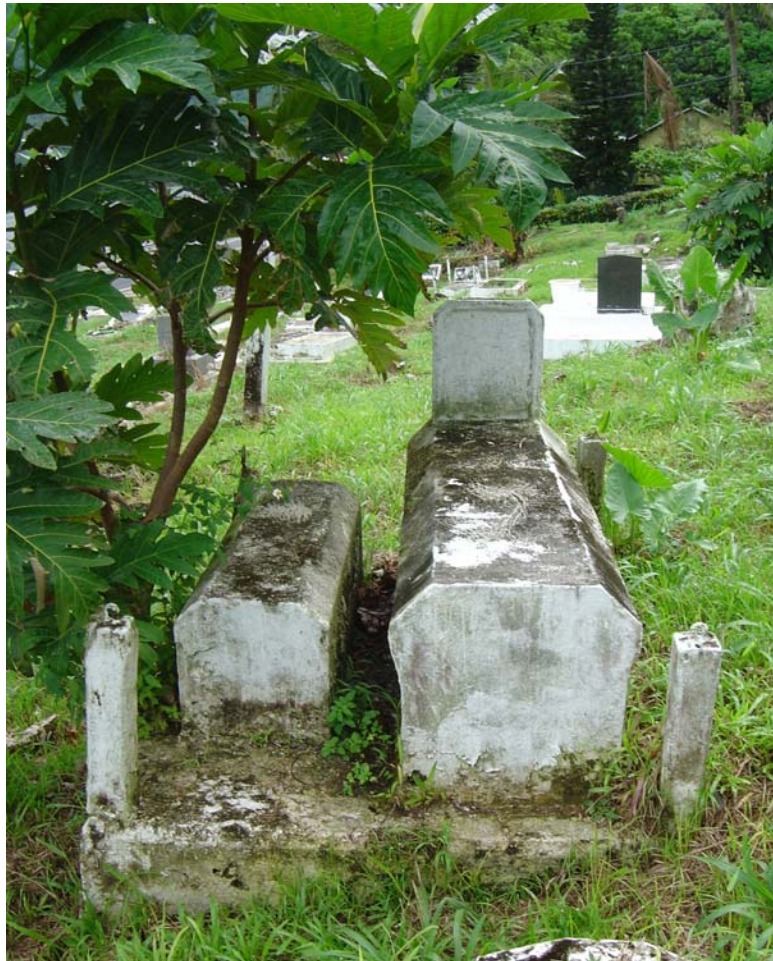
PHOTO:

SUMMARY: Four posts with missing chains for fence; SW corner post broken, chipped corner for SE post; grave consists of two casket style tombs and one unreadable headstone; entire grave covered in thick white paint and mildew; moss growing out of cracks in paint.

hazardous/immediate action **unstable deterioration/ASAP**
