CEMETERY SURVEY FORM

SITE NAME: Satala Naval Cemetery

LOCATION: Maoputasi County, Tutuila Island, American Samoa

PLOT IDENTIFICATION: 36

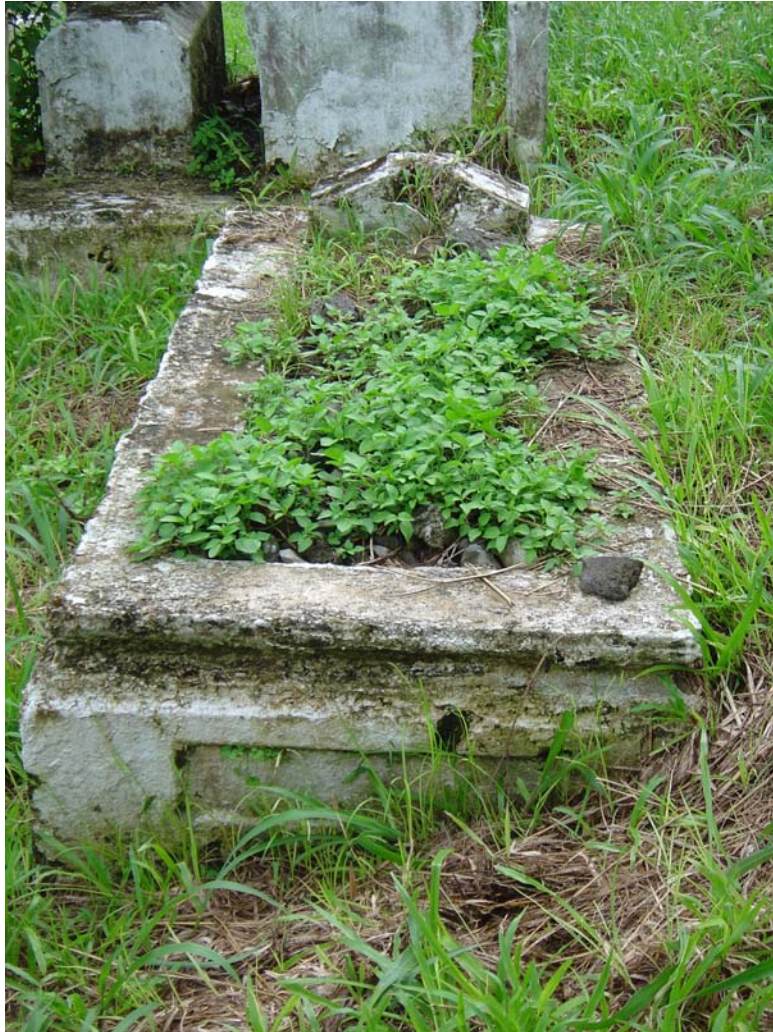
PHOTO:

SUMMARY: Open concrete frame filled with basalt and cobbles (water worn); overgrown, covered in thick white paint and mildew; base of possible headstone still in situ with big chunk broken, some pieces in with cobbles.

hazardous/immediate action **unstable deterioration/ASAP**
