CEMETERY SURVEY FORM

SITE NAME: Satala Naval Cemetery

LOCATION: Maoputasi County, Tutuila Island, American Samoa

PLOT IDENTIFICATION: 37

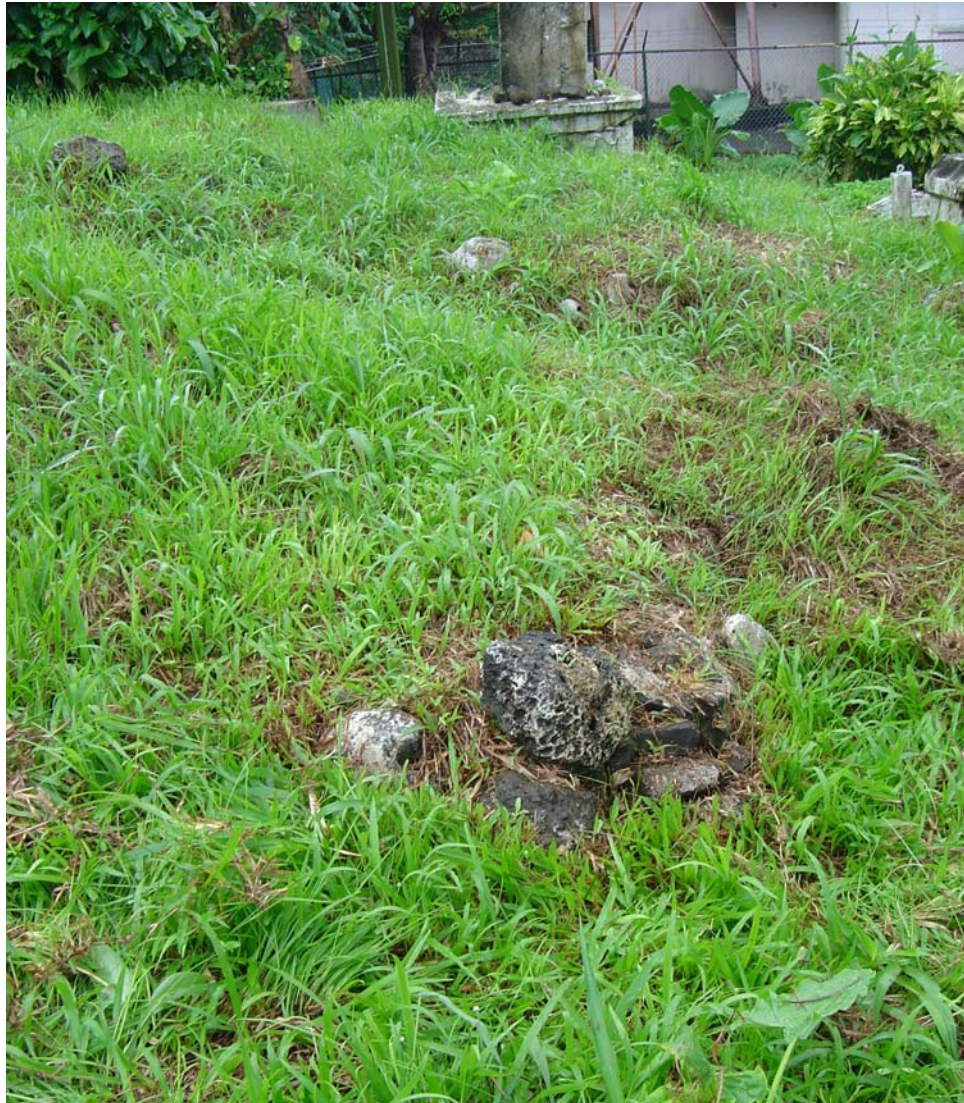
PHOTO:

SUMMARY: Overgrown rock oval outline with some painted rocks visible.
