CEMETERY SURVEY FORM

SITE NAME: Satala Naval Cemetery

LOCATION: Maoputasi County, Tutuila Island, American Samoa

PLOT IDENTIFICATION: 38

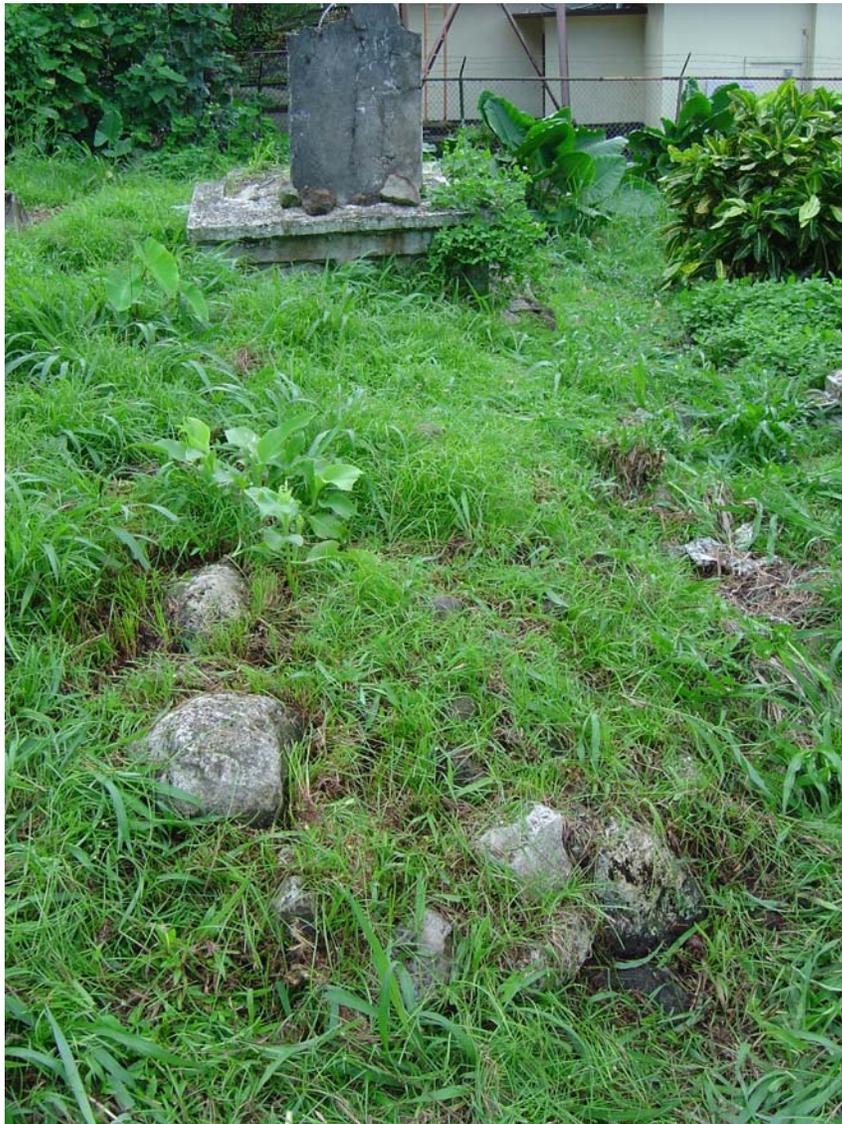
PHOTO:

SUMMARY: Overgrown rock mound with painted rock outline; rocks may be sliding downslope.

hazardous/immediate action **unstable deterioration/ASAP**
