CEMETERY SURVEY FORM

SITE NAME: Satala Naval Cemetery

PLOT IDENTIFICATION: 4

NAME(S) OF INTERRED: Stronach infant

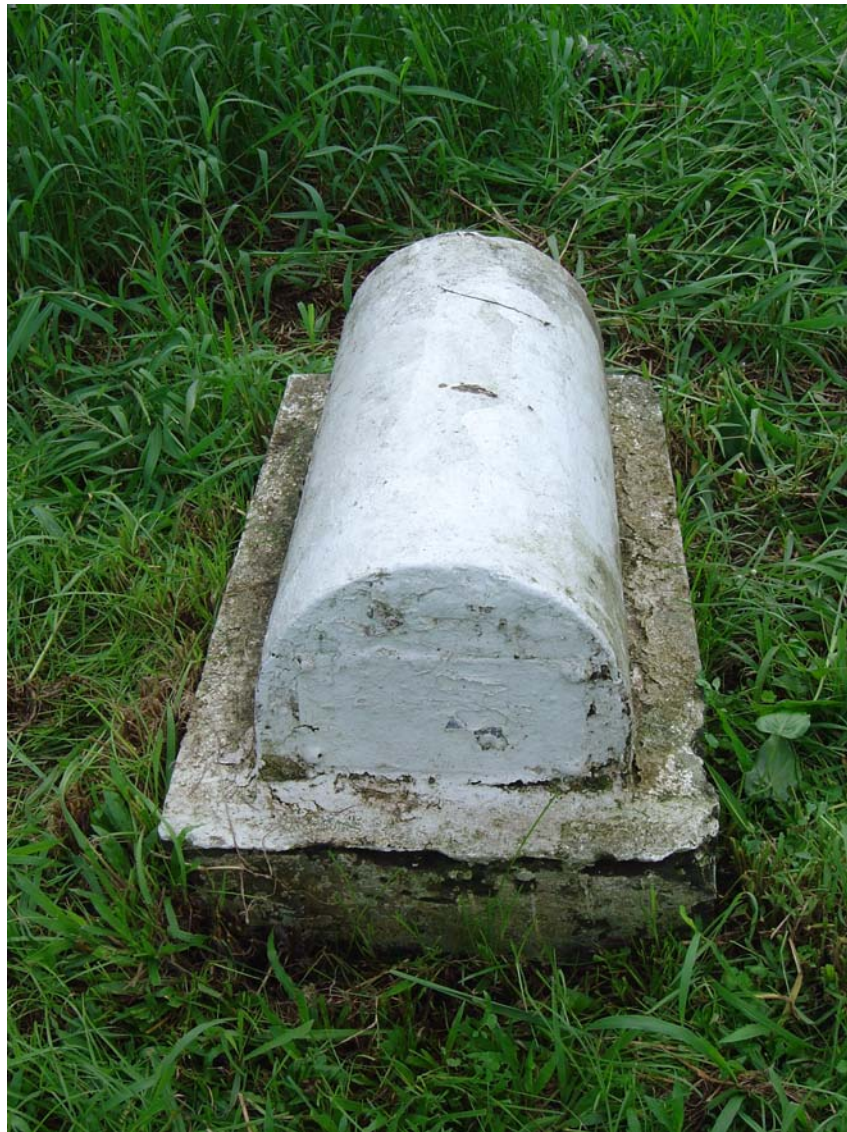
PHOTO:

SUMMARY: Plaque is completely covered in thick, white paint. SW corner of base is eroding out.
