# CEMETERY SURVEY FORM

SITE NAME: Satala Naval Cemetery

PLOT IDENTIFICATION: 40

NAME(S) OF INTERRED: FAALIGA

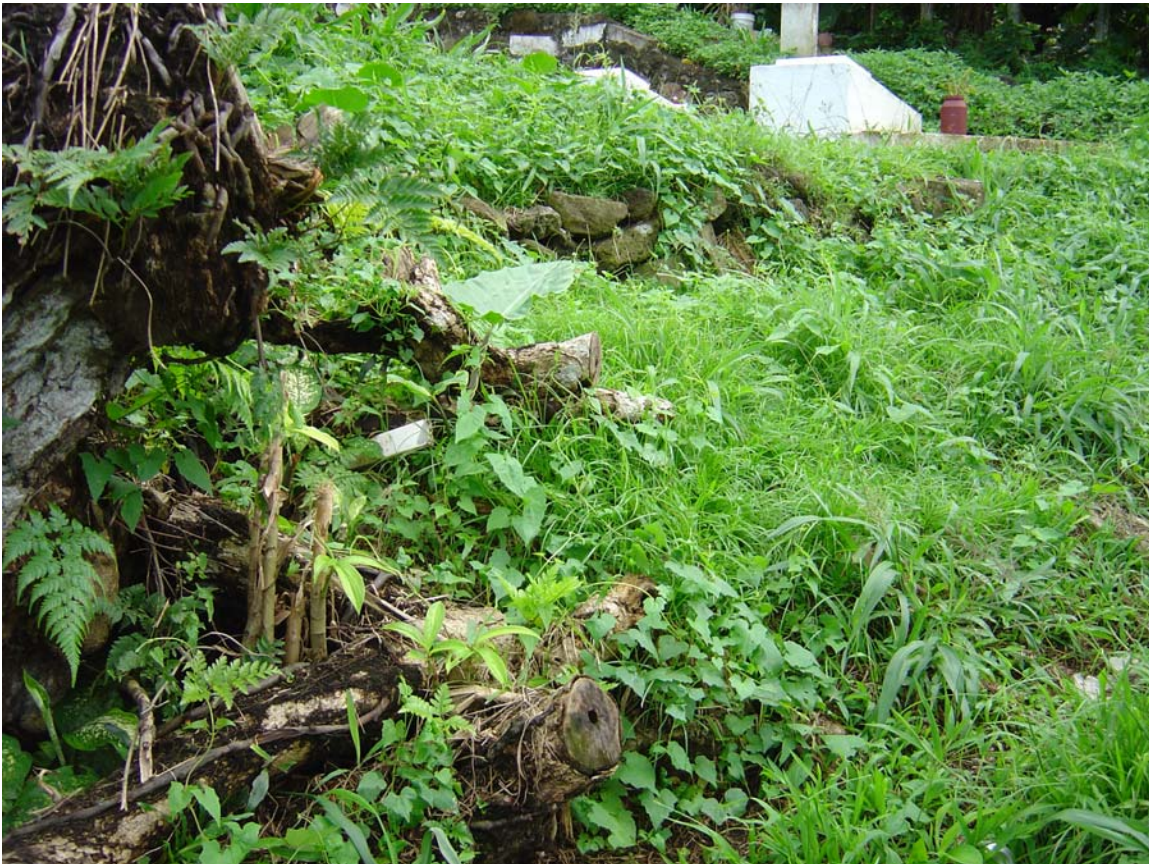
PHOTO:

SUMMARY: Large rock mound with ornamental shrub marking head? Dimensions are not clear due to overgrown vegetation. Flaking white paint and moss on visible rocks. E side may encounter erosion from previous flood damage; ditch running down slope on E side.
