# CEMETERY SURVEY FORM

SITE NAME: Satala Naval Cemetery

PLOT IDENTIFICATION: 41

NAME(S) OF INTERRED: A. P. BADGER

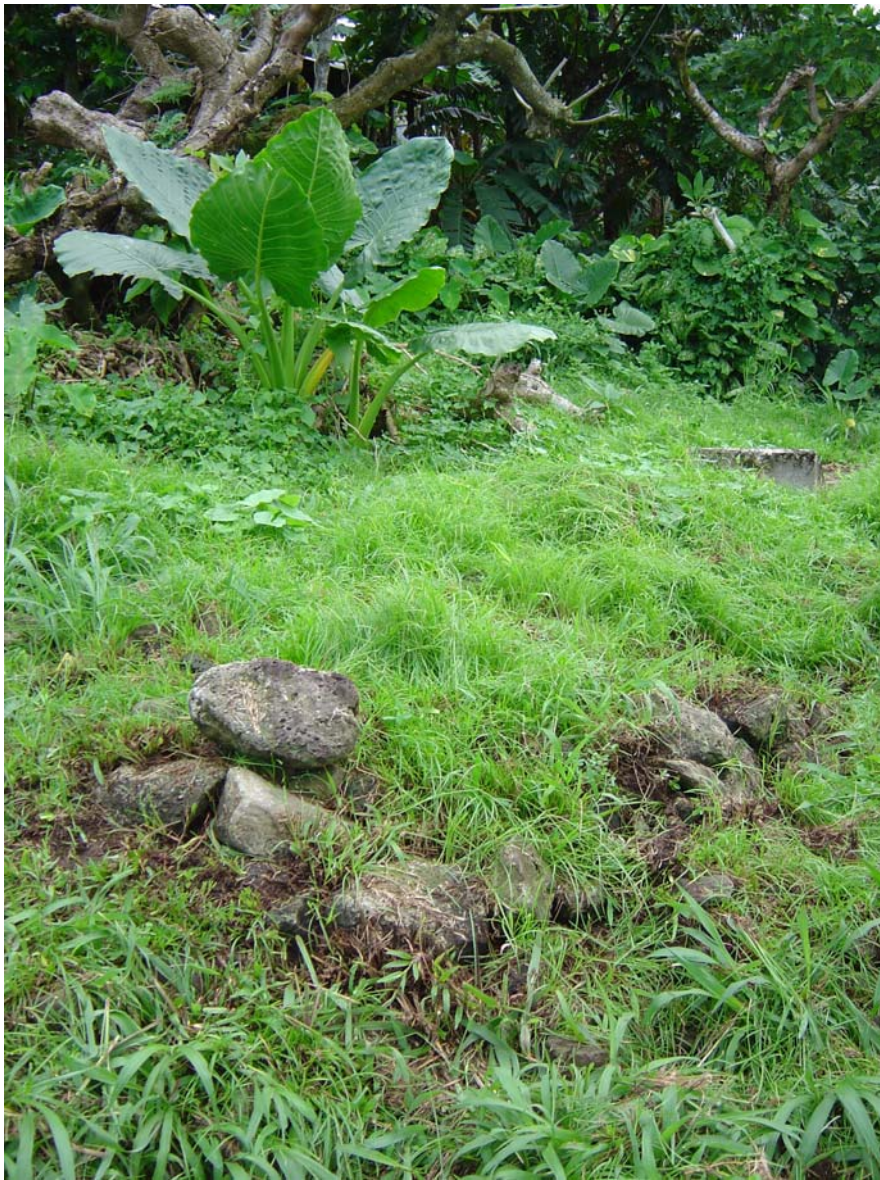
PHOTO:

EXISTING CONDITION	CONSERVATION STRATEGY
<p>POSITION: fallen unstable <b>overgrown</b> tilted marker/ base other _____</p> <p>DETERIORATION: ----- broken cracked losses flaking/sugaring delaminations/detachment other _____</p> <p>SOILING: <b>biological</b> general graffiti efflorescence <b>painting</b> other</p> <p>FAILED TREATMENTS: metal adhesives/coatings mortar other _____</p>	<p>POSITION: reset in ground reset to existing base resquare botom edge remove fragments in setting slot construct new base possible new base required stabilize foundation</p> <p>DETERIORATION: structural adhesion repair mortars crack fillers flowable grouts consolidation</p> <p>SOILING: chemical pressure wash poultice air abrasion</p> <p>FAILED TREATMENTS: drill/grind hand tools solvents air abrasion</p>

hazardous/immediate action **unstable deterioration/ASAP**

SUMMARY: Overgrown rock mound with visible rocks painted white. May be sliding downslope.
