# CEMETERY SURVEY FORM

SITE NAME: Satala Naval Cemetery

LOCATION: Maoputasi County, Tutuila Island, American Samoa

PLOT IDENTIFICATION: 44

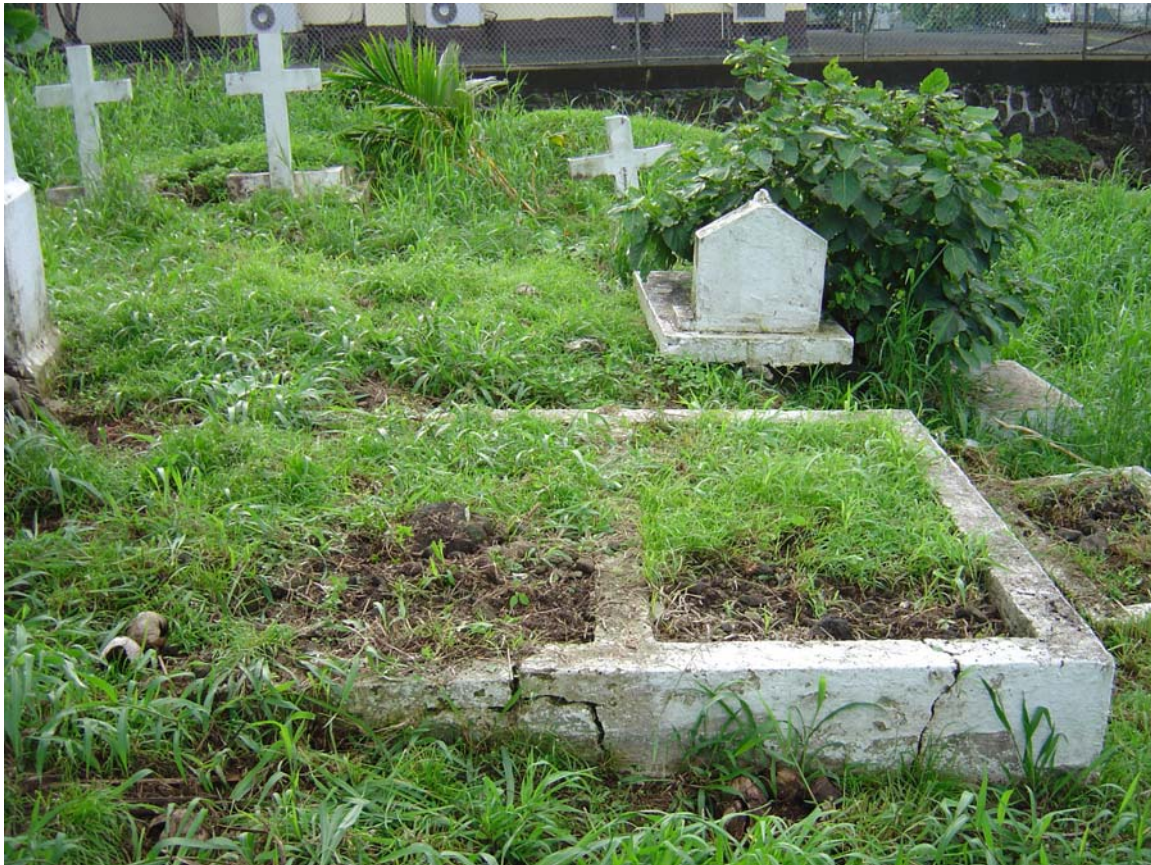
SUMMARY: Broken in SW corner near shared side with 16 and same with SE

Overgrown and covered in white paint and with mildew; flaking of concrete in exposed areas. Broken frame in southwest corner adjacent to grave 16.

PHOTO:        (44 is grave on left.)
