CEMETERY SURVEY FORM

SITE NAME: Satala Naval Cemetery

LOCATION: Maoputasi County, Tutuila Island, American Samoa

PLOT IDENTIFICATION: 47

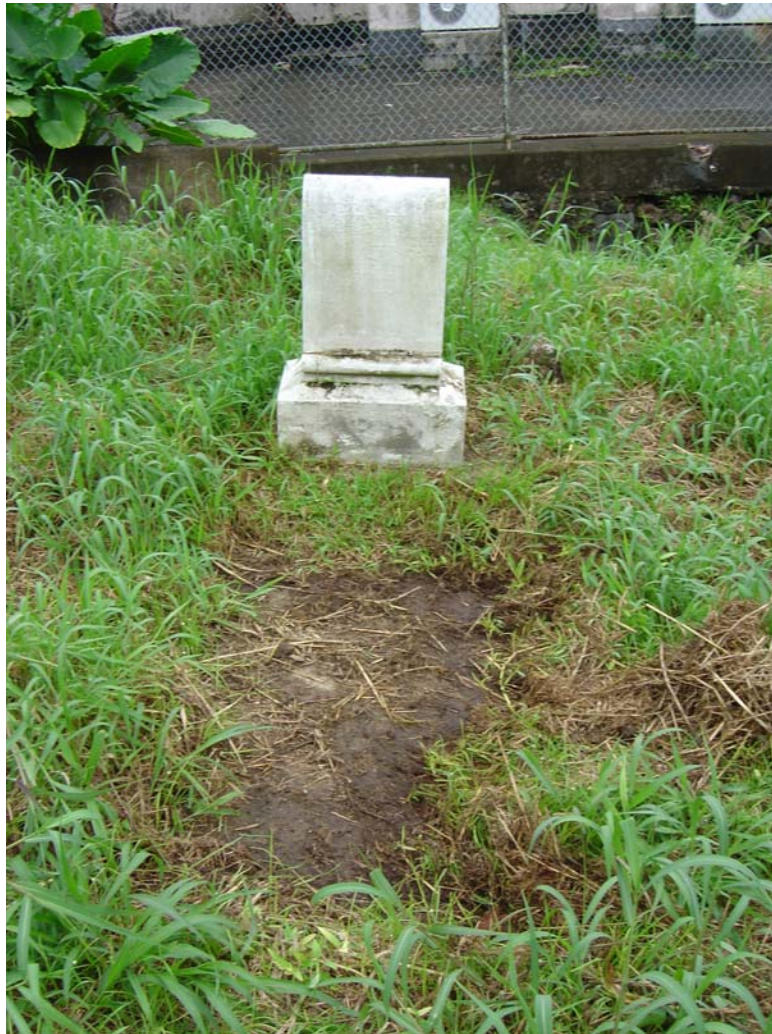
PHOTO:

EXISTING CONDITION	CONSERVATION STRATEGY
<p>POSITION:</p> <p>fallen unstable overgrown tilted marker/ base other <u>buried</u></p> <p>DETERIORATION: ----- broken cracked losses flaking/sugaring delaminations/detachment other _____</p> <p>SOILING:</p> <p>biological general graffiti efflorescence painting other</p> <p>FAILED TREATMENTS: ----- metal adhesives/coatings mortar other _____</p>	<p>POSITION:</p> <p>reset in ground reset to existing base resquare botom edge remove fragments in setting slot construct new base possible new base required stabilize foundation</p> <p>DETERIORATION:</p> <p>structural adhesion repair mortars crack fillers flowable grouts consolidation</p> <p>SOILING:</p> <p>chemical pressure wash poultice air abrasion</p> <p>FAILED TREATMENTS:</p> <p>drill/grind hand tools solvents air abrasion</p>

hazardous/immediate action **unstable deterioration/ASAP**

SUMMARY: Only top of primary structure visible; grave covered in 2003 flood. Headstone tilts down slope, covered in white paint and mildew. Currently illegible because of paint can be made out.
