CEMETERY SURVEY FORM

SITE NAME: Satala Naval Cemetery

LOCATION: Maoputasi County, Tutuila Island, American Samoa

PLOT IDENTIFICATION: 5

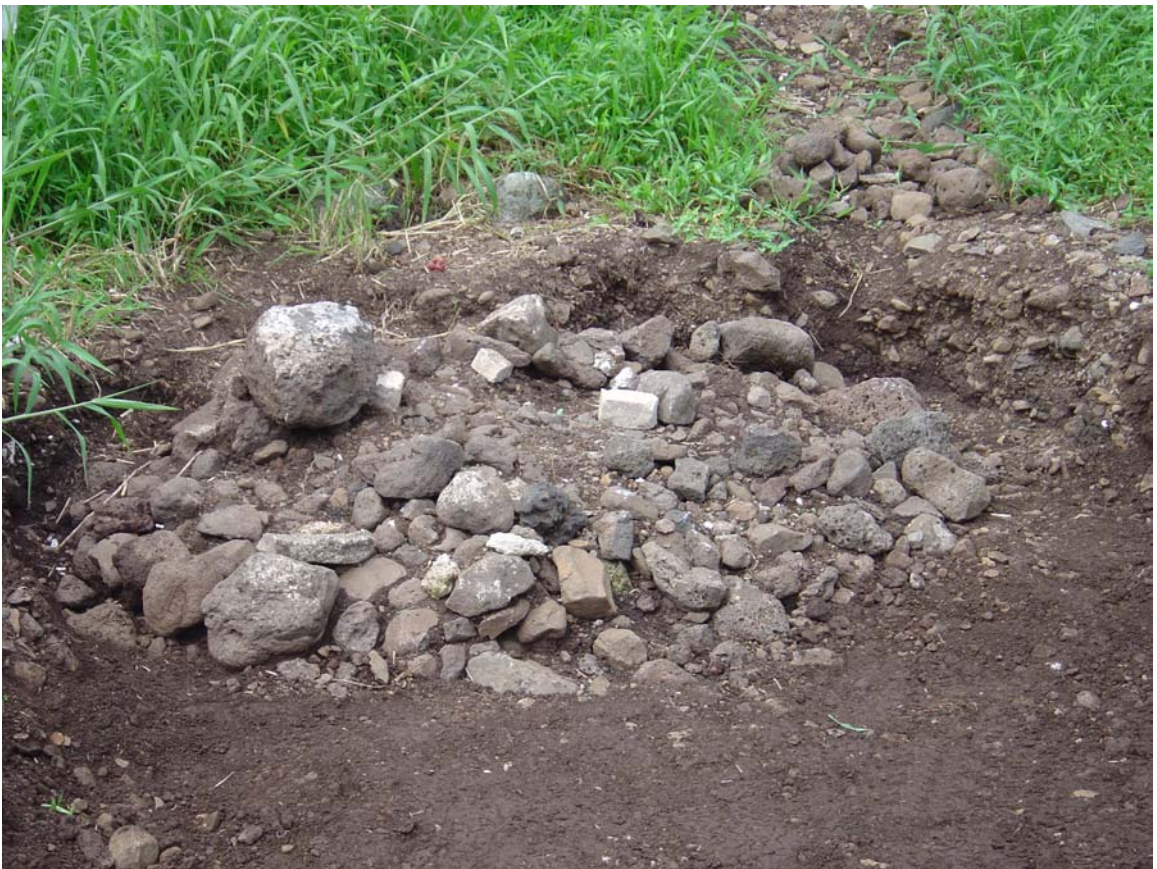
PHOTO:

SUMMARY: Needs to be weeded; recovered intact from 2003 flood; a few rocks are painted white.
